# Property Inspection Report

2384 San Diego Ave , San Diego , CA 92110  
Inspection prepared for: Rachel Parrott  
Date of Inspection: 11/23/2020 Time: 8:30 AM  
Age of Home: 1972 Size: 6888 Sqft  
Weather: Clear

Inspector: Eric Martinez  
NACHI12100924  
2122 W Mission Rd, Escondido, CA 92029  
Phone: 619-501-8282  
Email: emartinez@theinspectorscompany.com

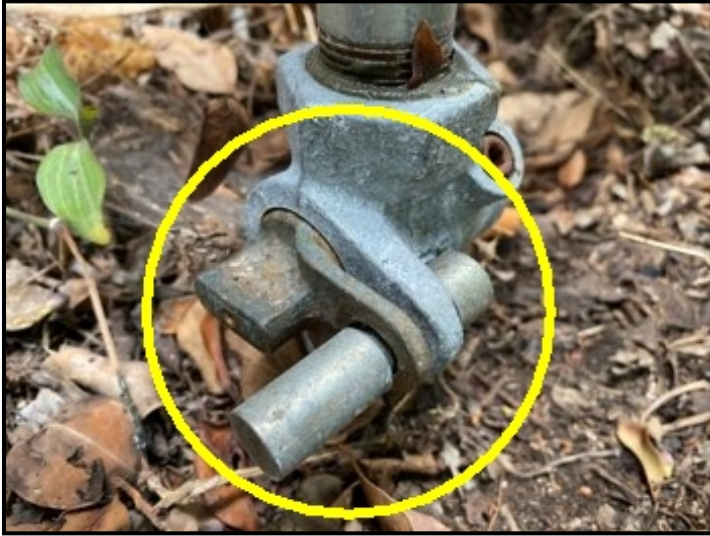
Grounds		
Page 25 Item: 6	Main gas Valve Condition	6.1. The gas service is off to the structure. The inspector cannot inspect this system. The main gas shut off valve is located at the gas meter. The unit was off and locked. No gas related items were tested. Advise testing before close of escrow.

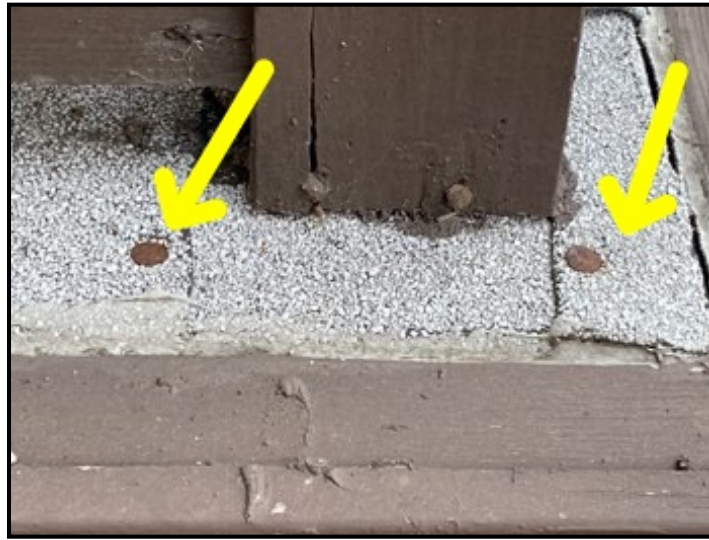
12.1. The balcony structure has a rolled cap sheet roofing material that has been improperly nailed onto the structure in various areas. Advise correction and repairs to prevent moisture intrusion.

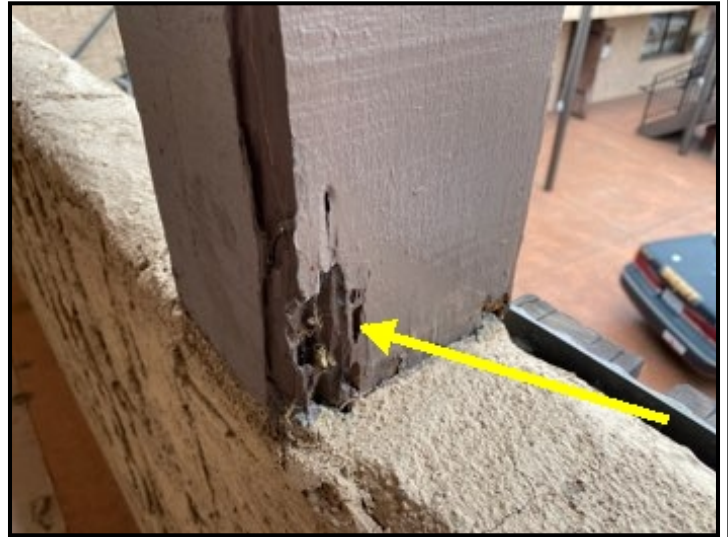
13.1. Dry rot and termite damage noted on the patio roof structures support columns. Seek a qualified licensed termite contractor for repairs and correction.

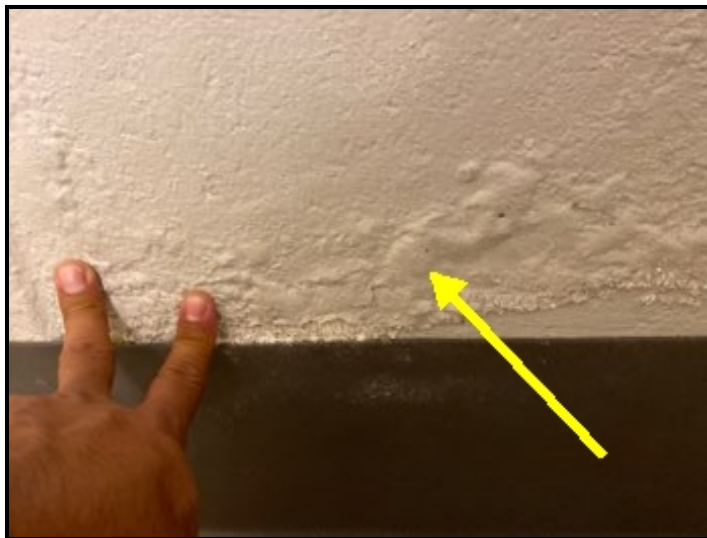
Page 32 Item: 3	Foundation Walls	3.1. There is efflorescence on the concrete foundation CMU block walls which confirms that moisture has penetrated the area and activated minerals that form a white powdery formation of salt crystals. This is a condition that should be monitored, and one that could produce musty odors.
-----------------	------------------	--

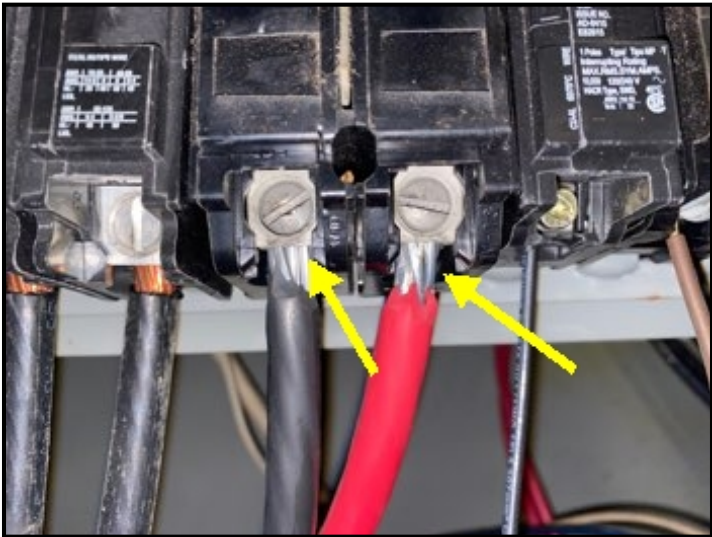
Roof		
Page 36 Item: 1	Roof Condition	1.3. The roof drains and roof needs to be serviced and cleaned of all organic debris and sediment. Seek a qualified licensed roofing contractor for repairs and maintenance.
Electrical		
Page 38 Item: 2	Electrical Panel	2.2. Recommend installing a proper closet around the meter switch board. It is not enclosed in a closet for safety. Seek a licensed contractor for repairs/correction.
Switch Board Panel		
Page 41 Item: 5	Wiring Observations	5.2. Recommend applying Aluminum antioxidant paste on the aluminium strand wiring as needed.

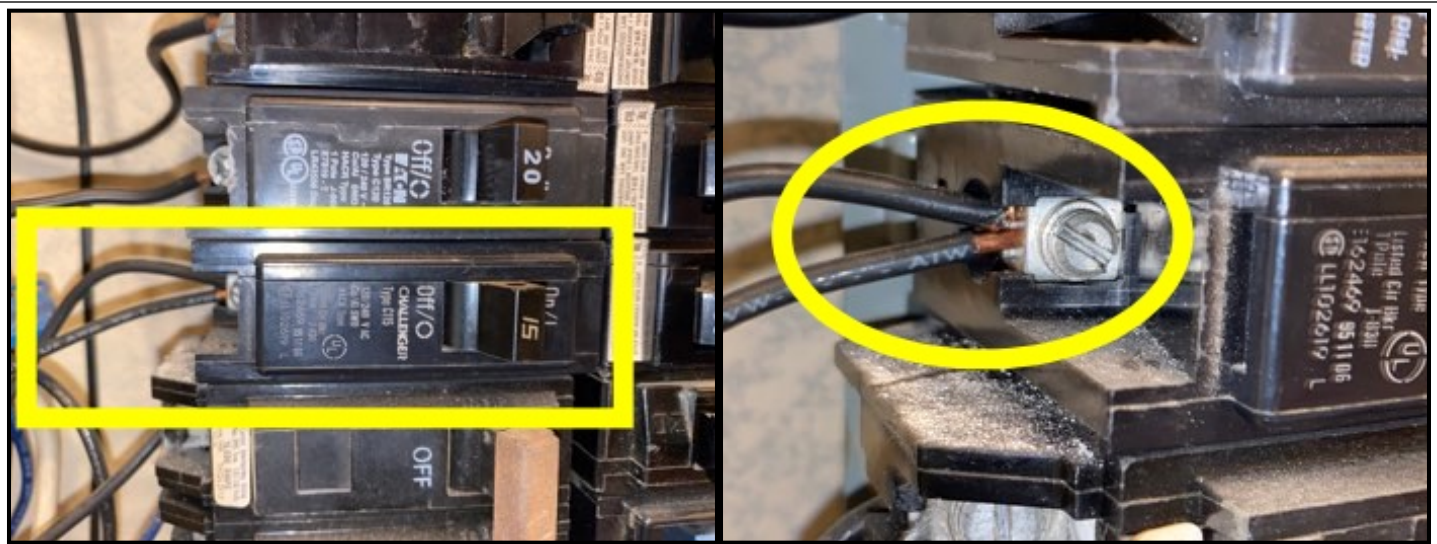
Upstairs Panel		
Page 43 Item: 3	Wiring Observations	<p>3.1. A single pole 15 amp breaker was observed to be "double tapped" in the sub panel. This does not meet current standards of practice and poses as a potential safety hazard. Seek a qualified licensed electrical contractor for further evaluations and repairs.</p> <p>3.2. There are neutral and ground wires in the electrical Sub Panel are being shared on the same bus bar. This may be consistent with time of construction but does not appear to meet current standards of practice and may pose a potential safety hazard. Seek a licensed electrical contractor for further evaluations and repairs.</p>

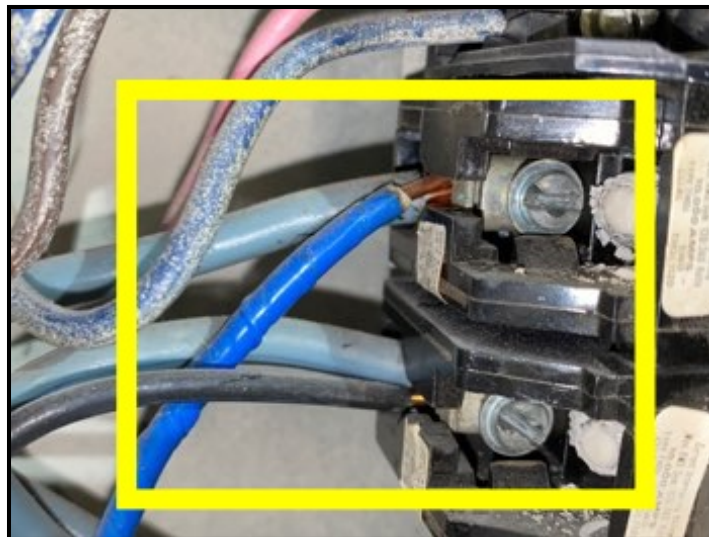
Page 46 Item: 3	Wiring Observations	3.2. Two single pole 20 amp breakers are “double tapped” in the sub panel. This does not meet current standards of practice and poses as a potential safety hazard. Seek a qualified licensed electrical contractor for further evaluations and repairs.
-----------------	---------------------	--

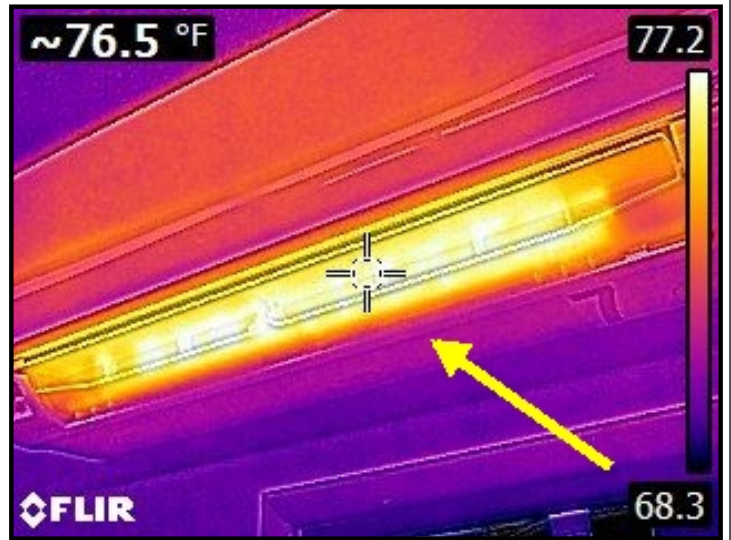
1.1. The number 7 Heat and AC mini split blows air, but heat and cool function did not work at the time of inspection. Seek a licenced HVAC technician for further evaluation and repairs.

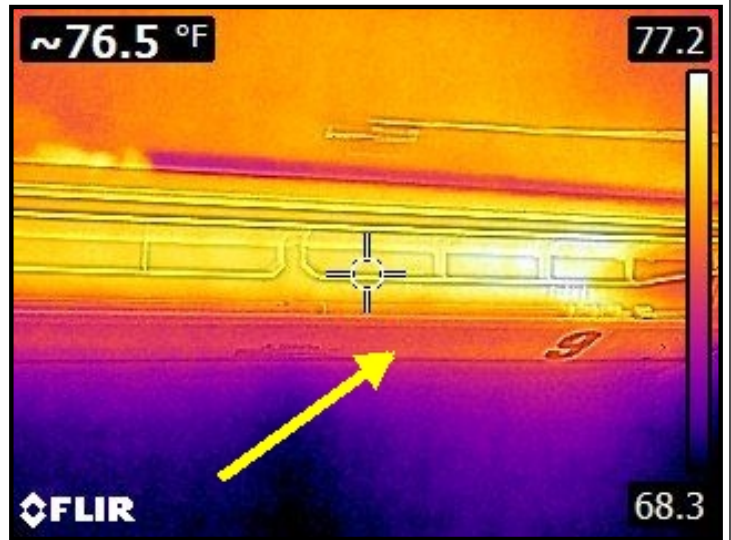
HVAC 9

Page 76 Item: 1	Heat/AC Mini Split	1.1. The #9 Heat and AC mini split blows air at the time of inspection, but the heat and cool function did not operate. Seek a licenced HVAC technician for further evaluation and repairs.
-----------------	--------------------	---

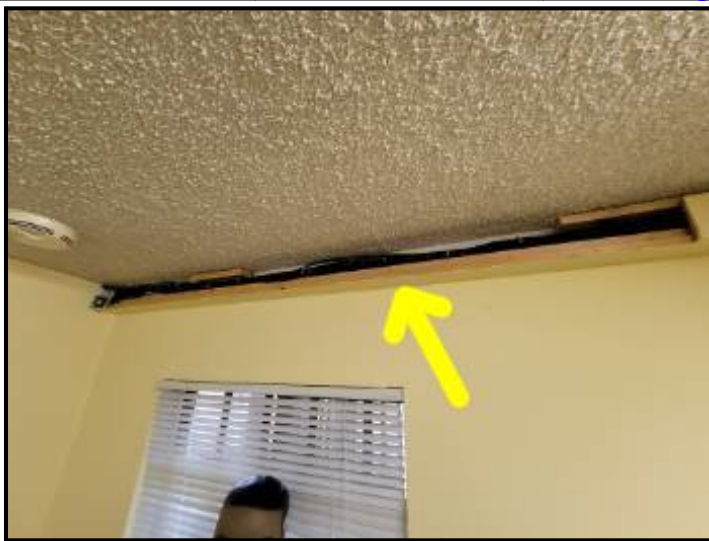
Page 108 Item: 4	Electrical	4.1. There are cover panels to the security system wiring that are missing.
------------------	------------	---

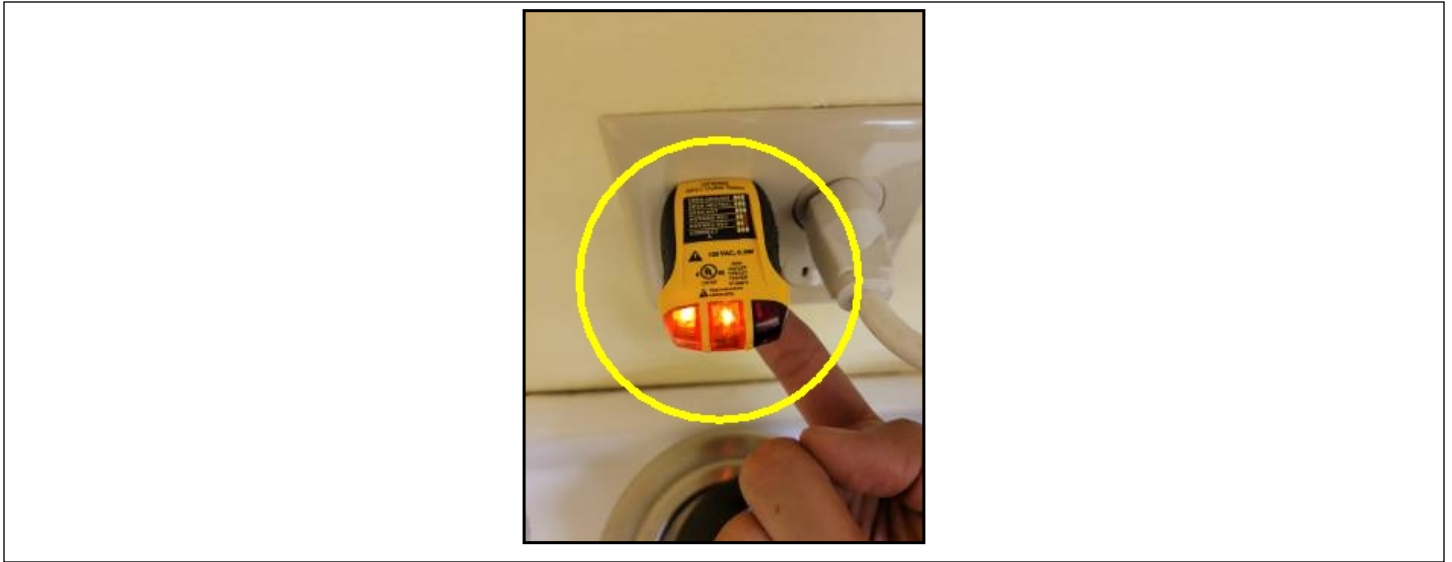
Page 110 Item: 3	Electrical	3.1. CAUTION: Unprotected wiring noted in one or more areas. This can be a possible safety concern. Recommend correcting advise repair by licensed electrical contractor.
------------------	------------	---

Page 110 Item: 4	GFCI	4.1. All Counter top outlets should be upgraded to have ground fault protection, which is mandated by current standards and is an important safety feature. Caution, potential safety shock hazard. Seek a licensed electrical contractor for repairs.
------------------	------	--

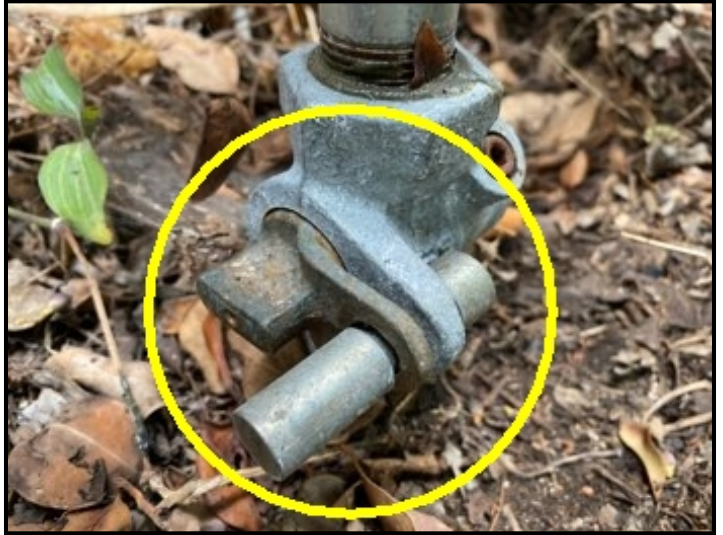
6.1. The gas service is off to the structure. The inspector cannot inspect this system. The main gas shut off valve is located at the gas meter. The unit was off and locked. No gas related items were tested. Advise testing before close of escrow.

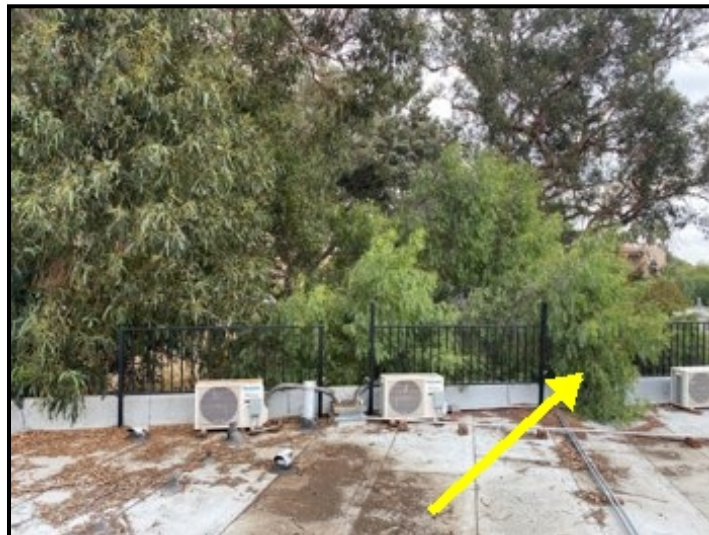
9.1. There are tree branches that are in contact with the roof. Trim trees that are in contact or proximity to home, as branches can abrade roofing or siding and cause damage. Refer to a licensed arborist/tree trimmer for repairs.

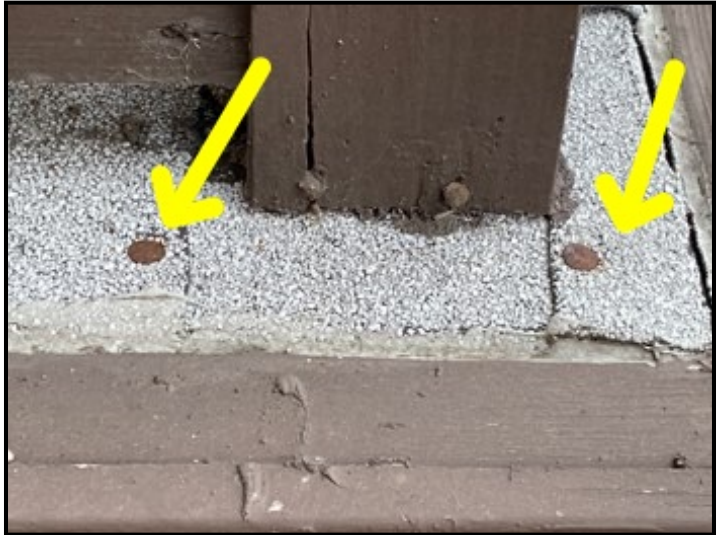
12.1. The balcony structure has a rolled cap sheet roofing material that has been improperly nailed onto the structure in various areas. Advise correction and repairs to prevent moisture intrusion.

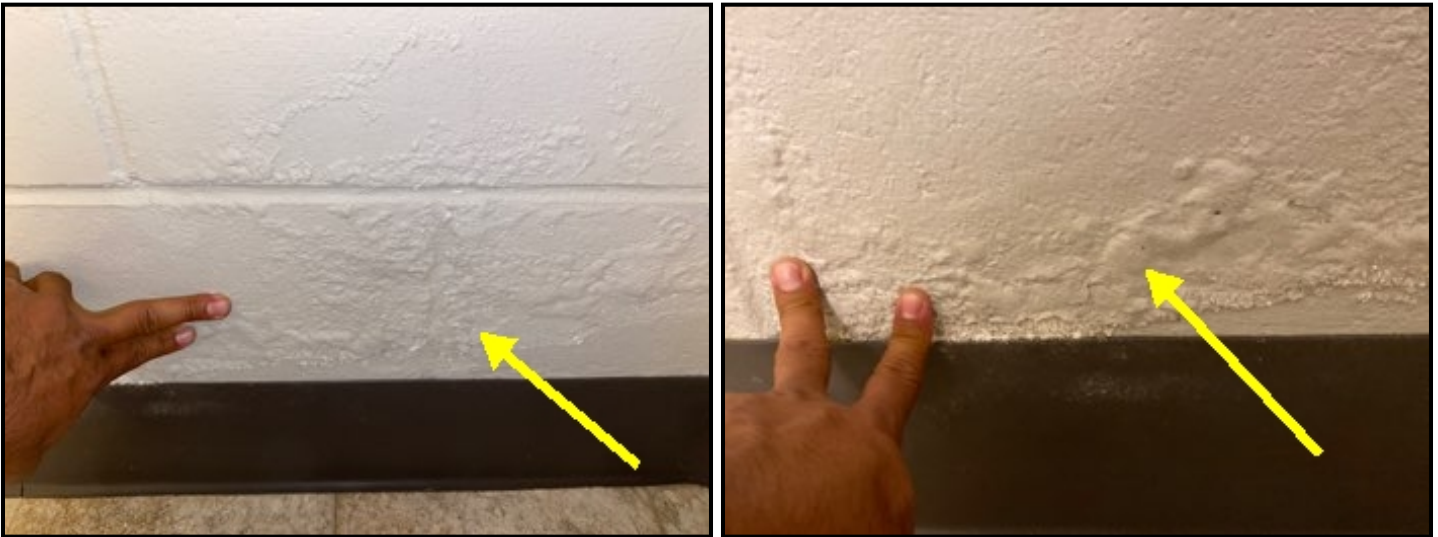
3.1. There is efflorescence on the concrete foundation CMU block walls which confirms that moisture has penetrated the area and activated minerals that form a white powdery formation of salt crystals. This is a condition that should be monitored, and one that could produce musty odors.

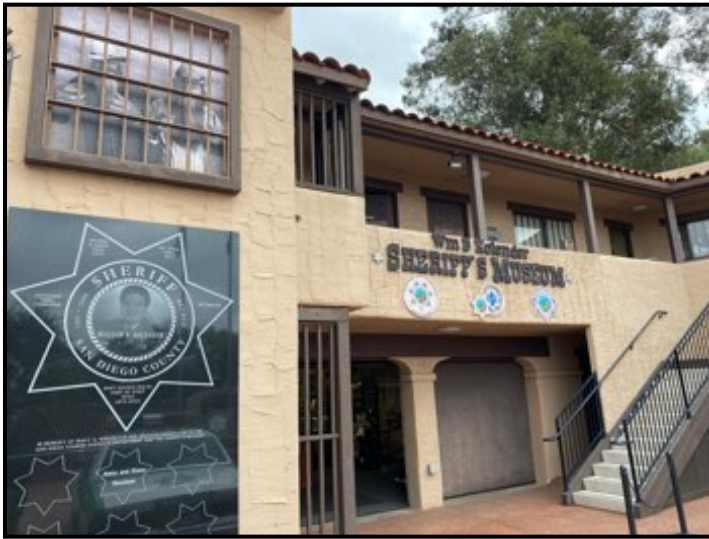
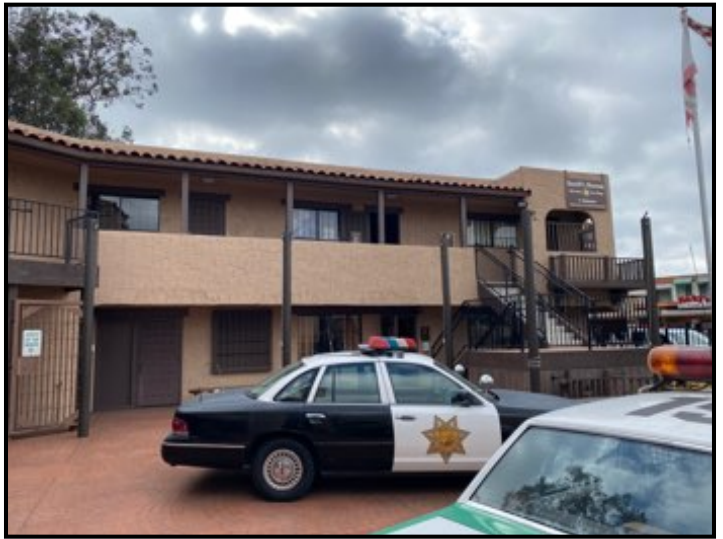
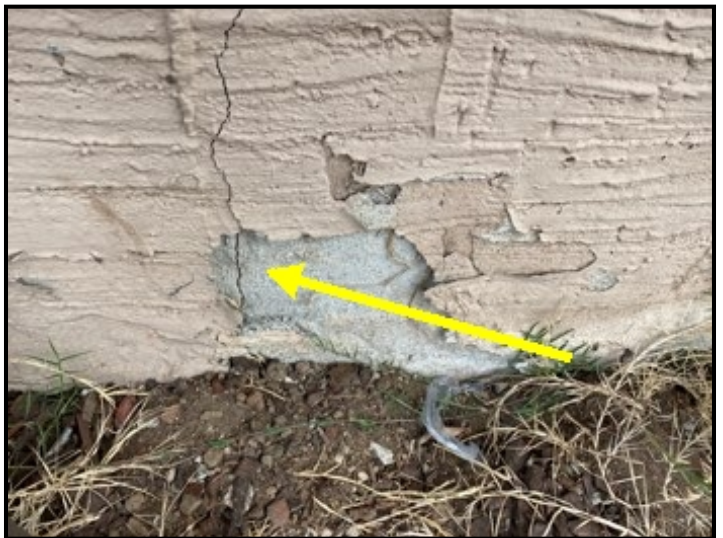
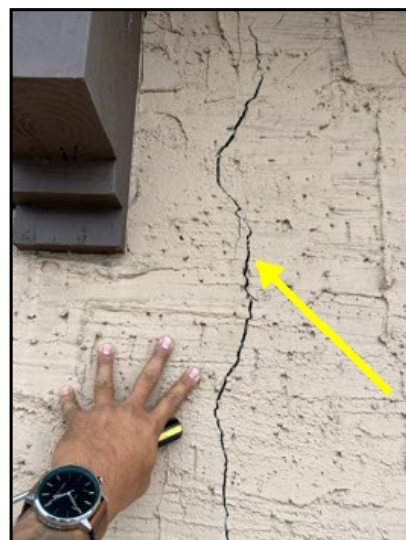
1.1. Cracked and chipped stucco observed in various locations. Seek a qualified licensed contractor for further evaluations and repairs.

1.2. Large cracks observed on the front facing side of the exterior building walls. These cracks could be a result of property settlement and movement to the foundation. The cracks are large enough where you should consult with a licensed foundation specialist and structural engineer for further deterioration to determine the buildings foundation actual condition.

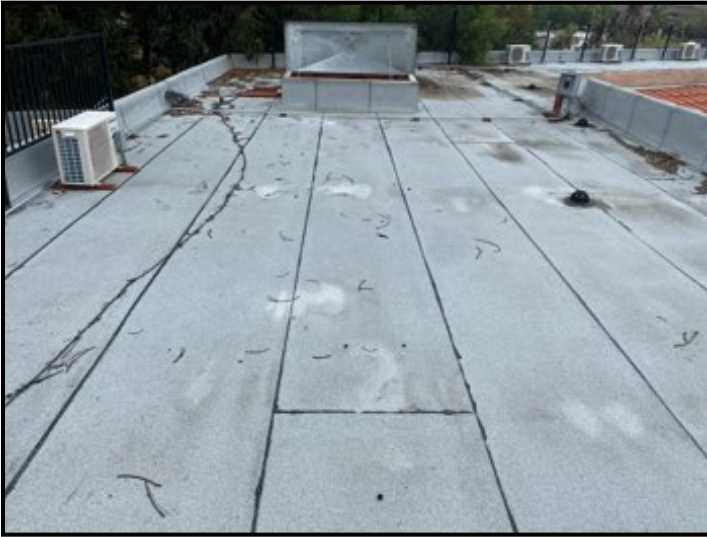
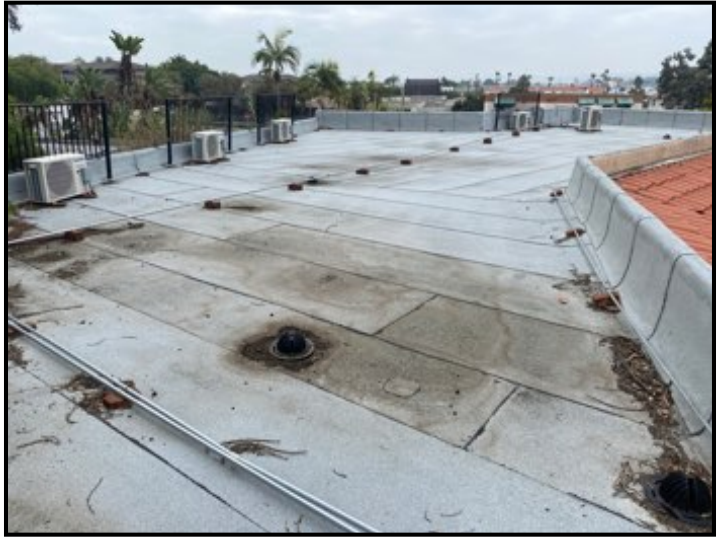
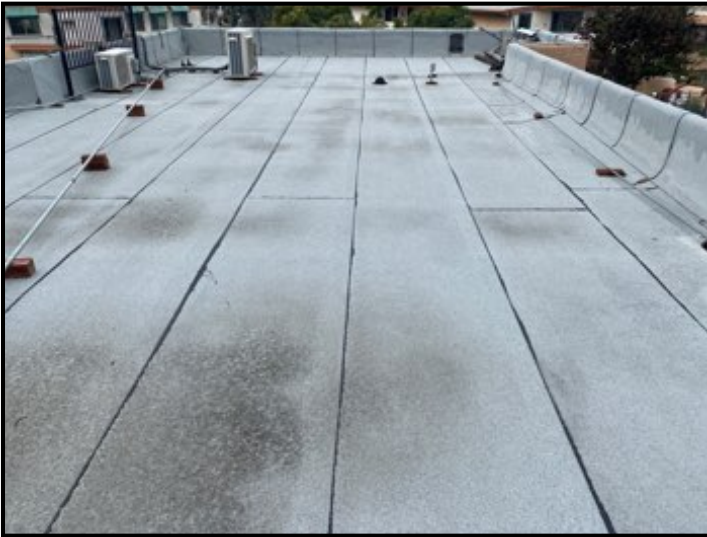
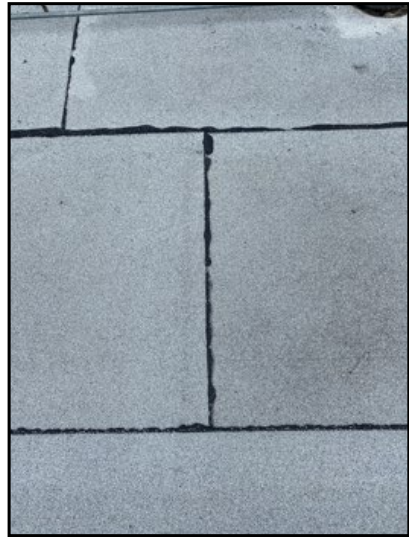
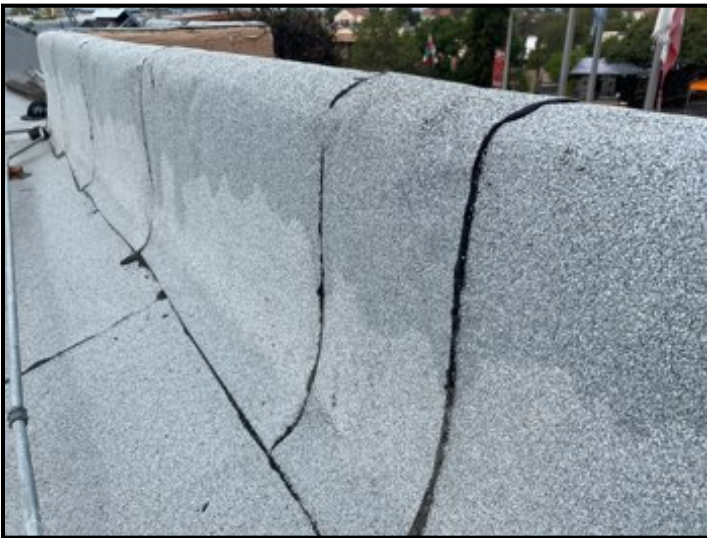
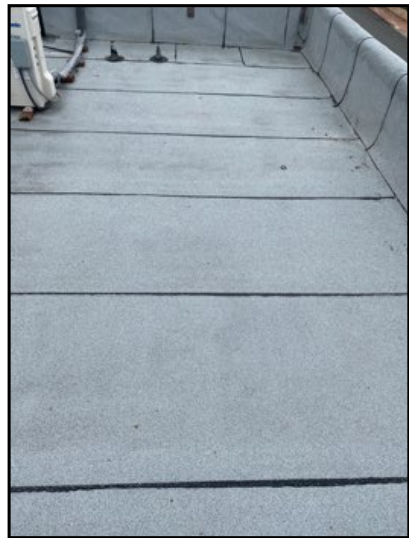
**1.3. The roof drains and roof needs to be serviced and cleaned of all organic debris and sediment. Seek a qualified licensed roofing contractor for repairs and maintenance.**

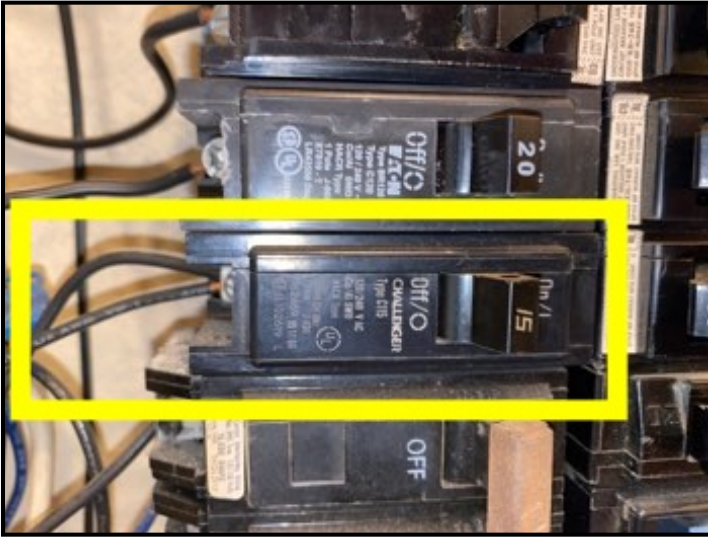
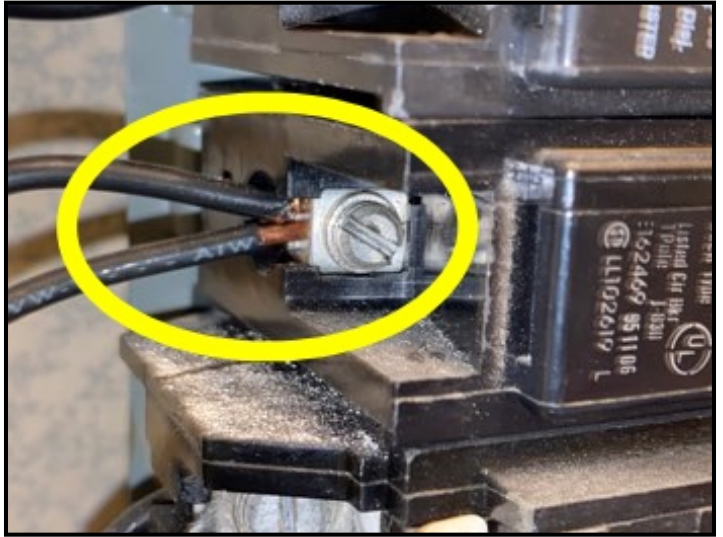
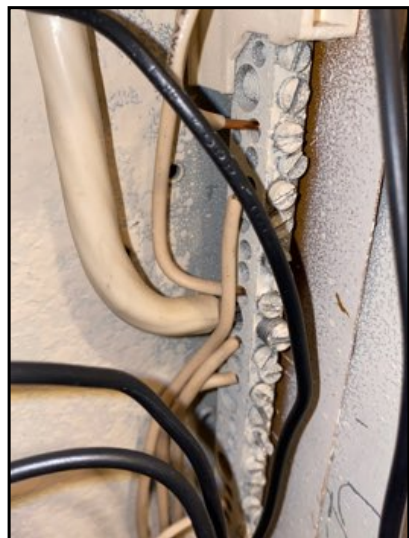
3.2. There are neutral and ground wires in the electrical Sub Panel are being shared on the same bus bar. This may be consistent with time of construction but does not appear to meet current standards of practice and may pose a potential safety hazard. Seek a licensed electrical contractor for further evaluations and repairs.

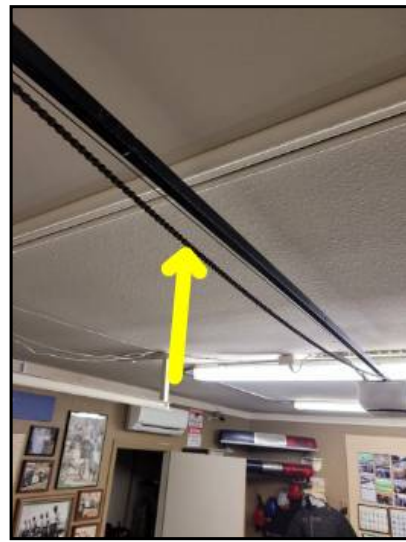
6.2. The left garage door opener chain is sagging. Seek a licensed garage door specialist for further evaluations and repairs

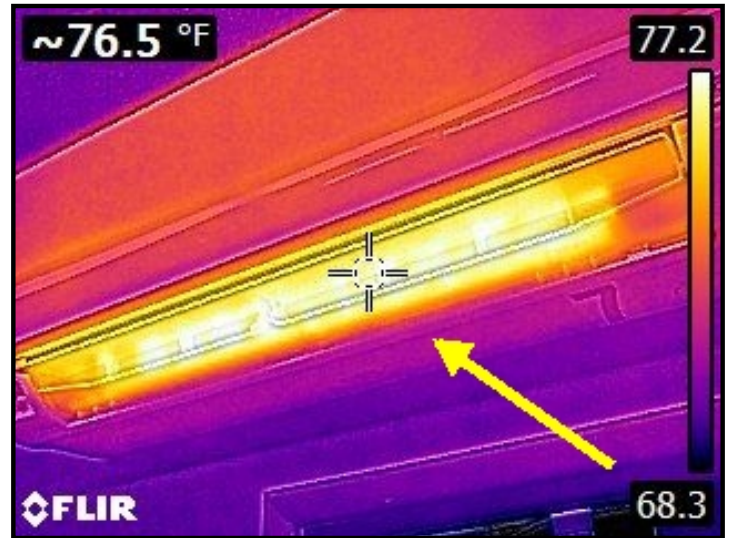
1.1. The number 7 Heat and AC mini split blows air, but heat and cool function did not work at the time of inspection. Seek a licenced HVAC technician for further evaluation and repairs.

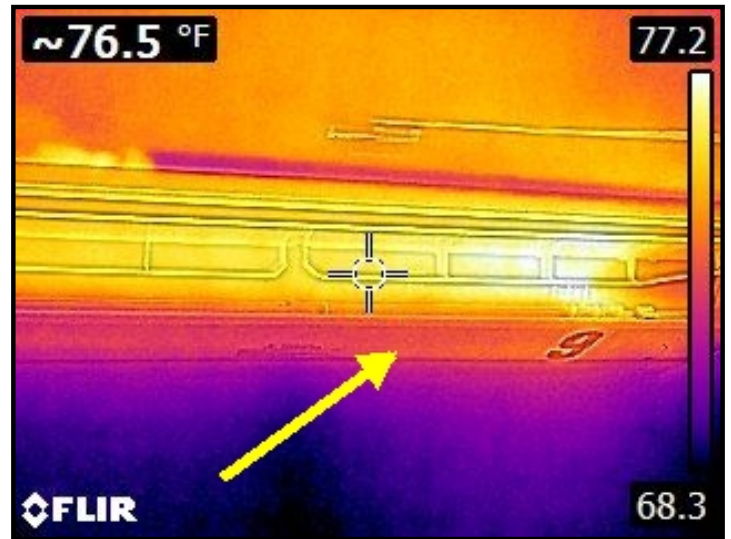
1.1. The #9 Heat and AC mini split blows air at the time of inspection, but the heat and cool function did not operate. Seek a licensed HVAC technician for further evaluation and repairs.

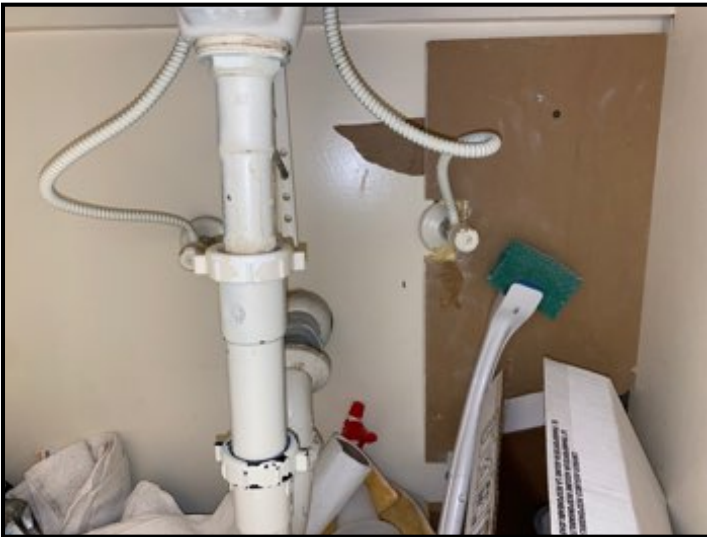
5.2. Older style water shut off valves and/or supply lines noted. Buyer is cautioned that these traps can leak at any time due to corrosion. Seek a qualified licensed plumbing contractor for repairs and replacement.

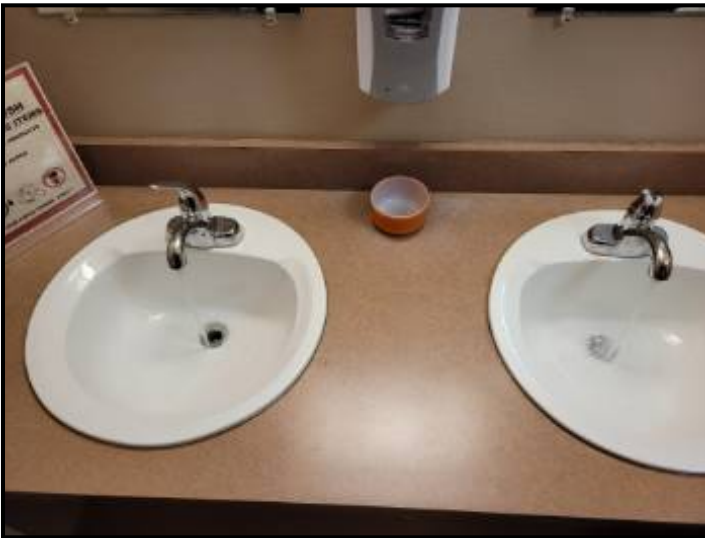
6.1. One or more sink stopper was observed missing/inoperable. Seek a licensed plumbing contractor for repairs.

6.2. Sink has a slow drain at one or more sink drain line. The sink drain appears to be partially blocked and should be serviced. This may be indicative of hair or debris obstructing the sink drain. Refer to a licensed plumbing contractor for further evaluations and repairs.

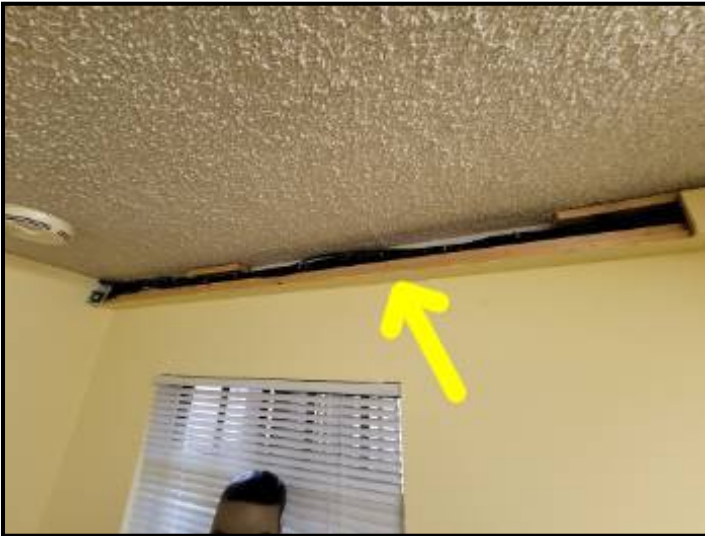
4.1. There are cover panels to the security system wiring that are missing.
