# Property Inspection Report

2384 San Diego Ave , San Diego , CA 92110  
Inspection prepared for: Rachel Parrott  
Date of Inspection: 11/23/2020 Time: 8:30 AM  
Age of Home: 1972 Size: 6888 Sqft  
Weather: Clear

Inspector: Eric Martinez  
NACHI12100924  
2122 W Mission Rd, Escondido, CA 92029  
Phone: 619-501-8282  
Email: emartinez@theinspectorscompany.com

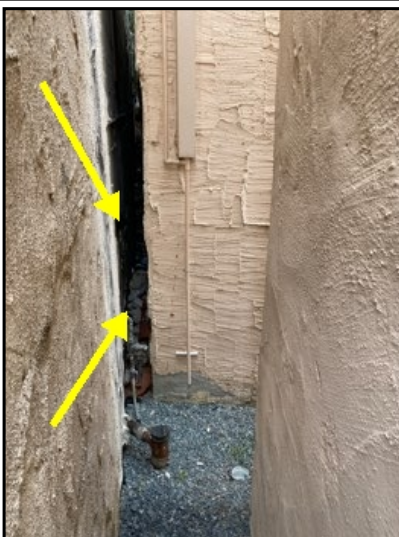
Page 26 Item: 8	Grading	8.4. There is a negative slope/improper storm water drainage at the rear of building and can cause or contribute to water intrusion or deterioration. Recommend further evaluation by a licensed grading and drainage contractor to determine corrections needed at this time.

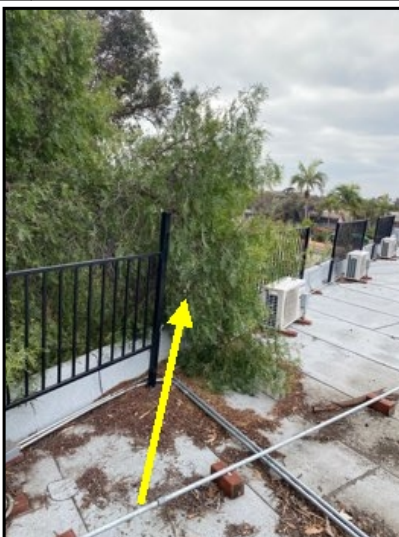
Page 27 Item: 9

9.1. There are tree branches that are in contact with the roof. Trim trees that are in contact or proximity to home, as branches can abrade roofing or siding and cause damage. Refer to a licensed arborist/tree trimmer for repairs.

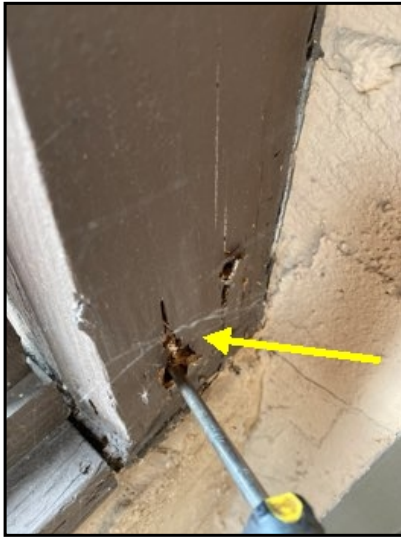
Page 29 Item: 13 | Patio Enclosure

13.1. Dry rot and termite damage noted on the patio roof structures support columns. Seek a qualified licensed termite contractor for repairs and correction.

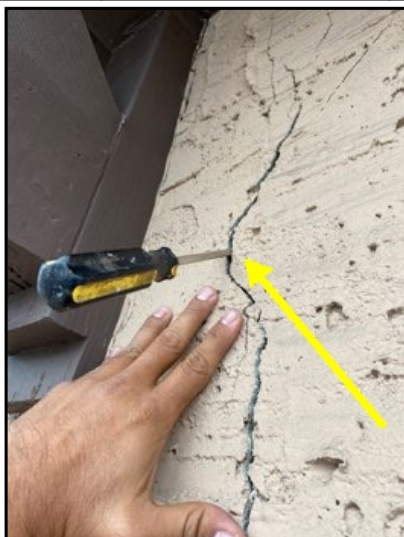
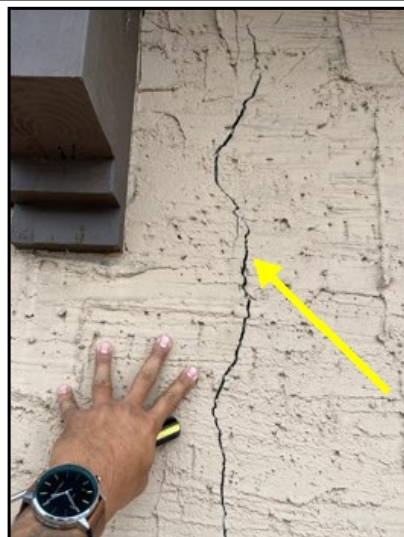
Page 34 Item: 1	Stucco	<p>1.1. Cracked and chipped stucco observed in various locations. Seek a qualified licensed contractor for further evaluations and repairs.</p> <p>1.2. Large cracks observed on the front facing side of the exterior building walls. These cracks could be a result of property settlement and movement to the foundation. The cracks are large enough where you should consult with a licensed foundation specialist and structural engineer for further deterioration to determine the buildings foundation actual condition.</p>
-----------------	--------	---

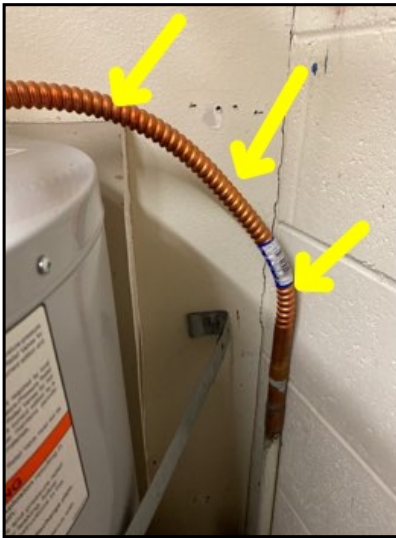
Page 50 Item: 2	Water Heater Condition	2.1. The water heater could not be fully evaluated or turned on at the time of inspection. The gas meter was shut off to the building. Refer to San Diego Gas and Electric to turn on the gas an re inspect the appliance.
Page 51 Item: 5	TPRV	5.2. CAUTION: The temperature relieve valves discharge pipe appears to be a threaded flexible type which does not meet current standards of practice. This is a potential safety hazard. Seek further evaluations by a licensed plumbing contractor.

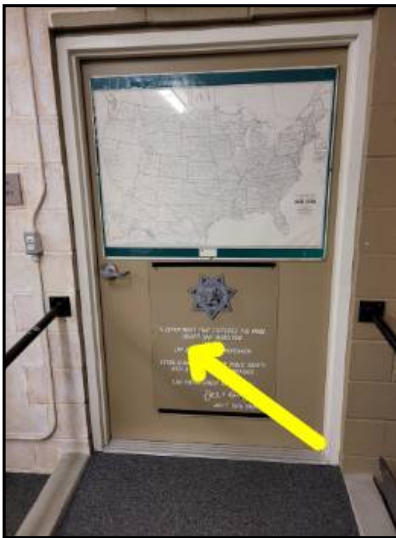
Page 54 Item: 1	Common Observations	1.1. Due to occupants personal items, not all areas were visible. Advise a careful evaluation during final walk-through.
Page 55 Item: 2	Fire Door	2.1. The large door to the lower interior area is not fully self-closing and is required to be, to maintain the necessary firewall separation between a garage and living quarters, and will need to be serviced. Caution potential fire and safety hazard. Refer to a licensed contractor for approved repairs.

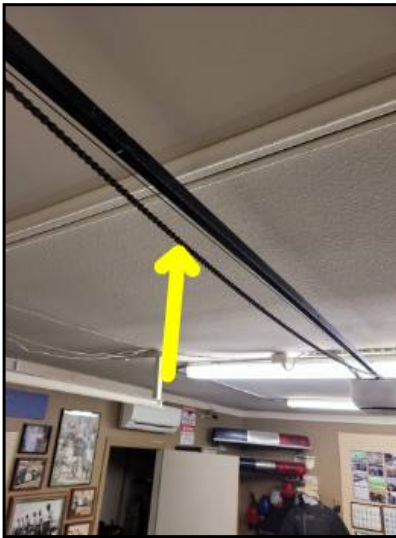
Page 57 Item: 6	Garage Door Parts	6.2. The left garage door opener chain is sagging. Seek a licensed garage door specialist for further evaluations and repairs
-----------------	-------------------	---

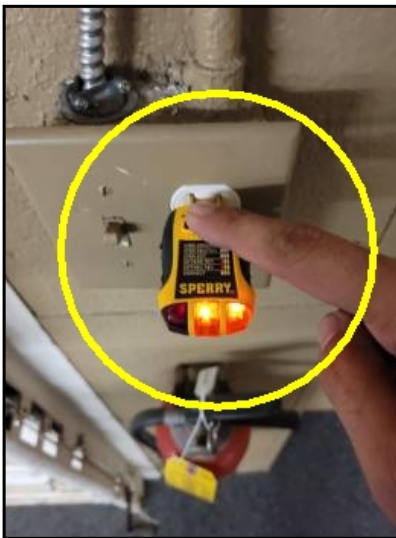
Page 58 Item: 8

8.1. The outlets should be upgraded to have ground fault protection, which is mandated by current standards and is an important safety feature. Caution, potential safety shock hazard.

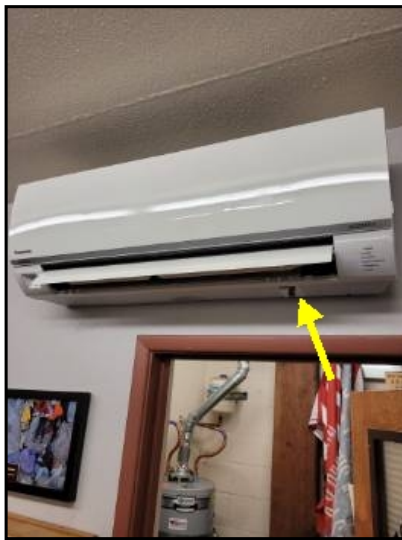
Page 73 Item: 1

1.1. The number 7 Heat and AC mini split blows air, but heat and cool function did not work at the time of inspection. Seek a licenced HVAC technician for further evaluation and repairs.

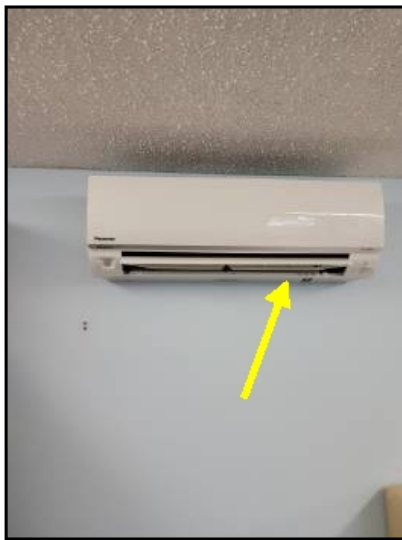
Page 76 Item: 1	Heat/AC Mini Split	1.1. The #9 Heat and AC mini split blows air at the time of inspection, but the heat and cool function did not operate. Seek a licenced HVAC technician for further evaluation and repairs.
-----------------	--------------------	---

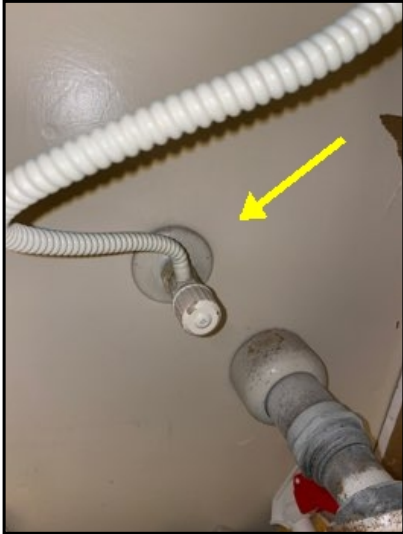
Page 82 Item: 5	Plumbing	5.2. Older style water shut off valves and/or supply lines noted. Buyer is cautioned that these traps can leak at any time due to corrosion. Seek a qualified licensed plumbing contractor for repairs and replacement.

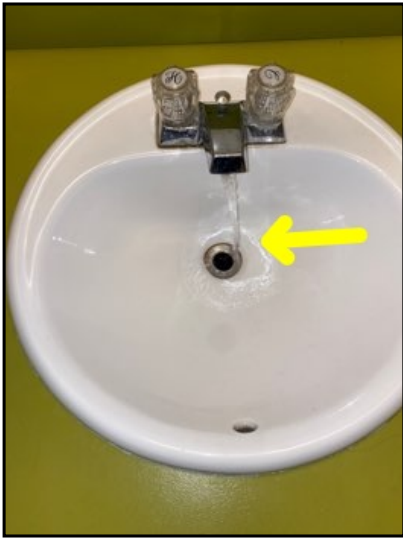
Page 82 Item: 7	Sinks	7.1. The bathroom sink stopper was observed missing/inoperable. Seek a licensed plumbing contractor for repairs.

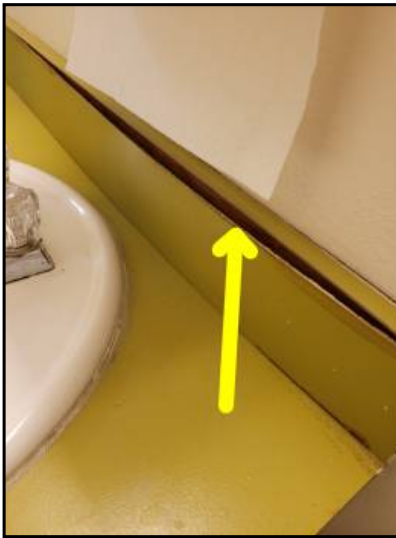
Southside Office Bathroom		
Page 84 Item: 3	Counters	3.1. The counter tops appear to be worn and damaged. Seek a licensed contractor for repairs.

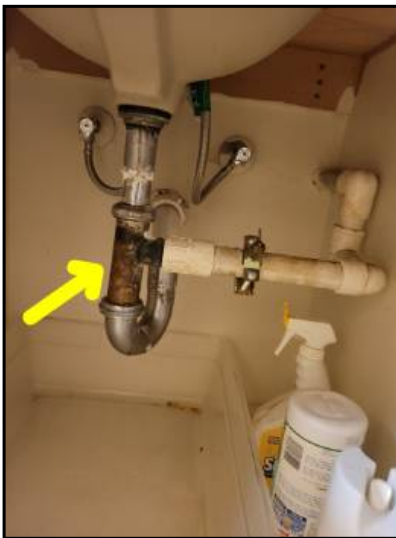
Page 85 Item: 5

5.2. The bathrooms waste pipes were observed with signs of corrosion/build up at the fittings. This is susceptible to water leaks and moisture intrusion. Refer to a licensed plumbing contractor for repairs.

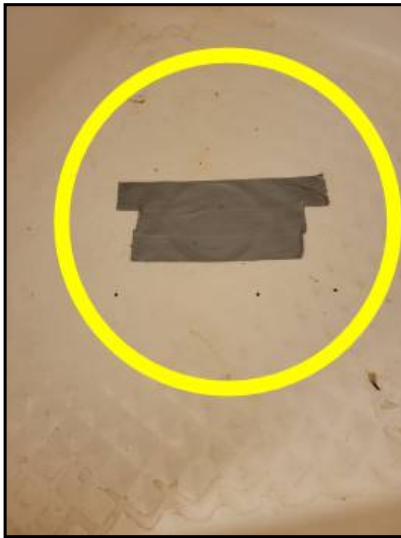
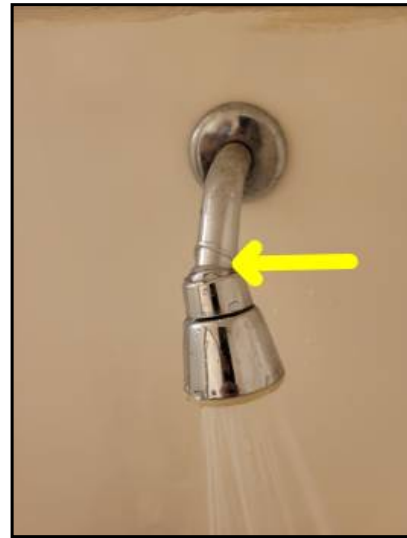
Page 86 Item: 6

6.1. The bathroom shower actively drips when in operation. Seek a licensed plumbing contractor for repairs.

6.2. The shower drain was duct taped over at initial time of inspection. We peeled it back and checked the shower drainage. The shower drained adequately at the time of inspection. Refer to sellers for information pertaining to the taped drain.

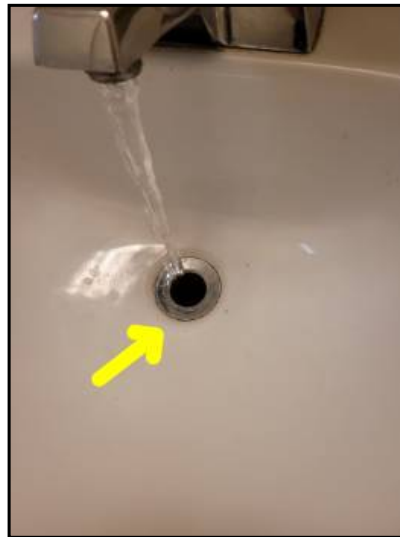
Page 87 Item: 7

7.1. The bathroom sink stopper was observed missing/inoperable. Seek a licensed plumbing contractor for repairs.

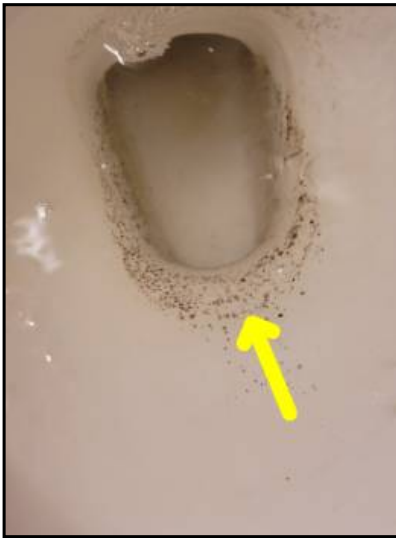
Page 87 Item: 8

8.1. Signs of mold like substance observed in the toilet. This could be due to lack of use.

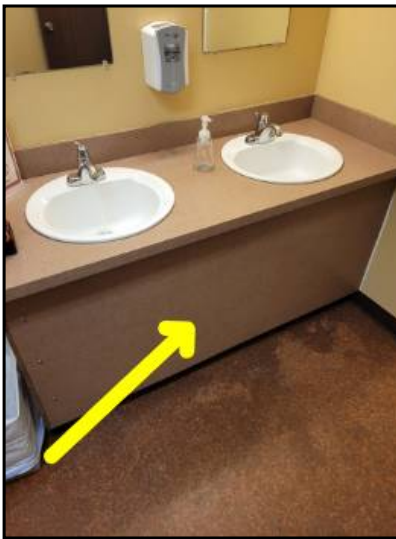
Page 89 Item: 2

2.1. The counters should pedestal style sinks so that a person in a wheelchair is capable of sink use. Per commercial standards at least one sink must be capable for a handicapped accessibility. The front cover board of the sink area restricts wheelchair access. Seek a licensed contractor for further evaluations and repairs.

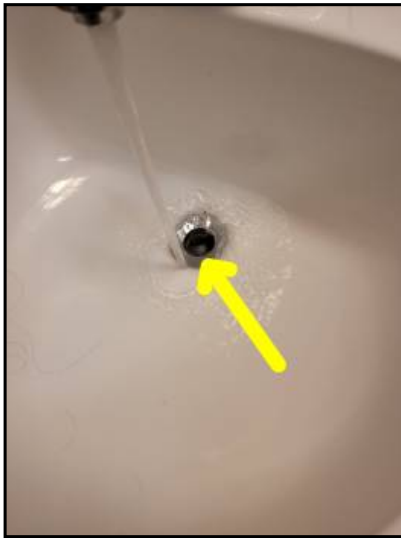
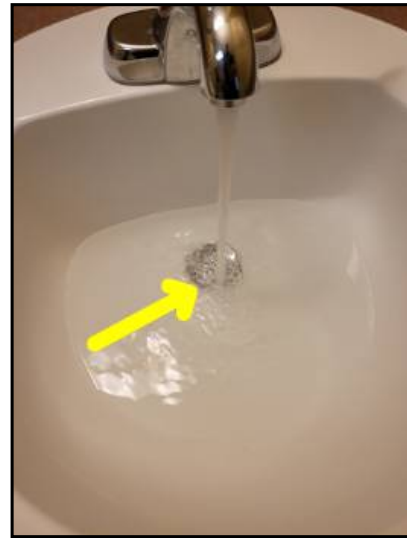
Page 93 Item: 6

6.1. One or more sink stopper was observed missing/inoperable. Seek a licensed plumbing contractor for repairs.

6.2. Sink has a slow drain at one or more sink drain line. The sink drain appears to be partially blocked and should be serviced. This may be indicative of hair or debris obstructing the sink drain. Refer to a licensed plumbing contractor for further evaluations and repairs.

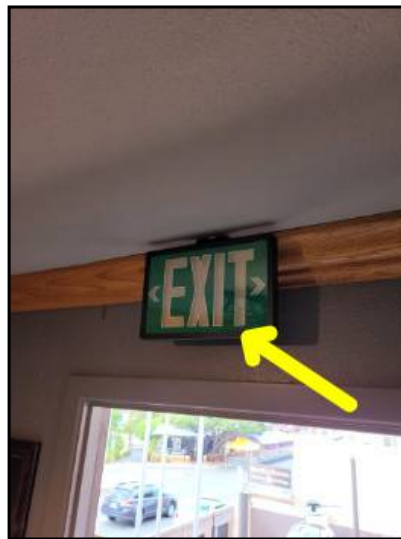
Page 96 Item: 1	Observations	1.2. The exit signs should be illuminated for easy spotting.
-----------------	--------------	--

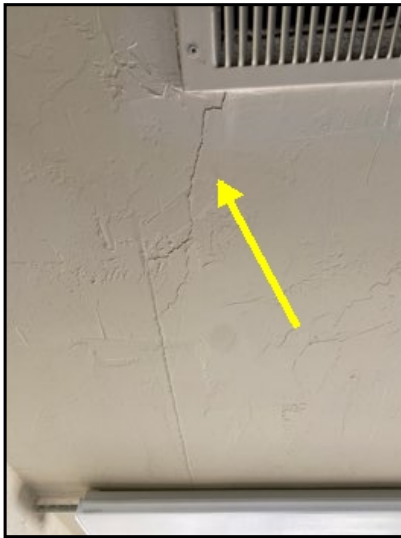
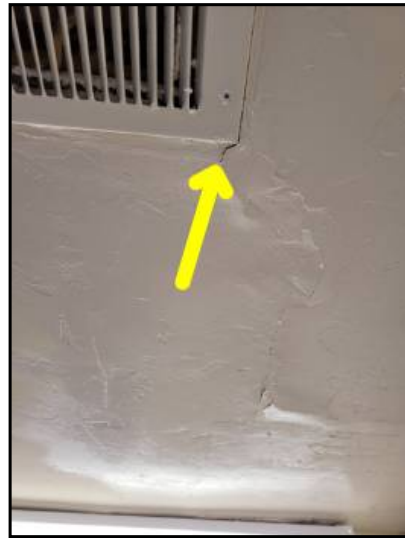
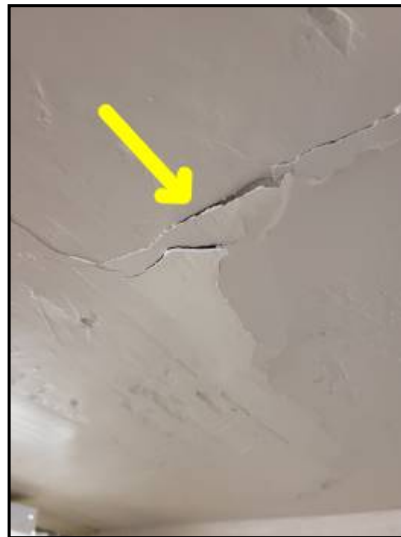
Page 102 Item: 2	Ceiling Condition	<p>2.1. Acoustic texture, also known as "popcorn", was present at the ceilings. This material was often used from the late 1950s into the 1980s in residential construction. Some of this material installed before the 80's has been known to contain asbestos. It is beyond the scope of this inspection to test for asbestos. The only way to confirm the presence or absence of asbestos is by having a sample of the material tested in a lab. If client has any concerns regarding asbestos materials, an asbestos-testing lab should be consulted for further review.</p> <p>2.2. Evidence of water staining was observed at the second level ceiling in one or more areas. Conditions tested dry with the thermal imaging camera at the time of inspection. Refer to the sellers and sellers disclosure to advise. Monitor conditions.</p> <p>2.3. The ceilings appear to have typical stress fractures. You may wish to have this further evaluated by a qualified expert and repair as needed.</p> <p>2.4. There appeared to be evidence of a repair noted on the ceiling in one or more location.</p>

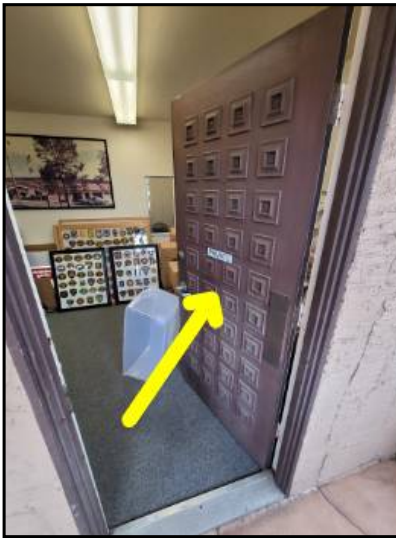
Page 104 Item: 3 Doors

3.1. We recommend the doors to swing outward. Being that this building is a commercial property, all doors should swing outward for proper fire egress and escape. Seek a licensed contractor for further evaluations and repairs.

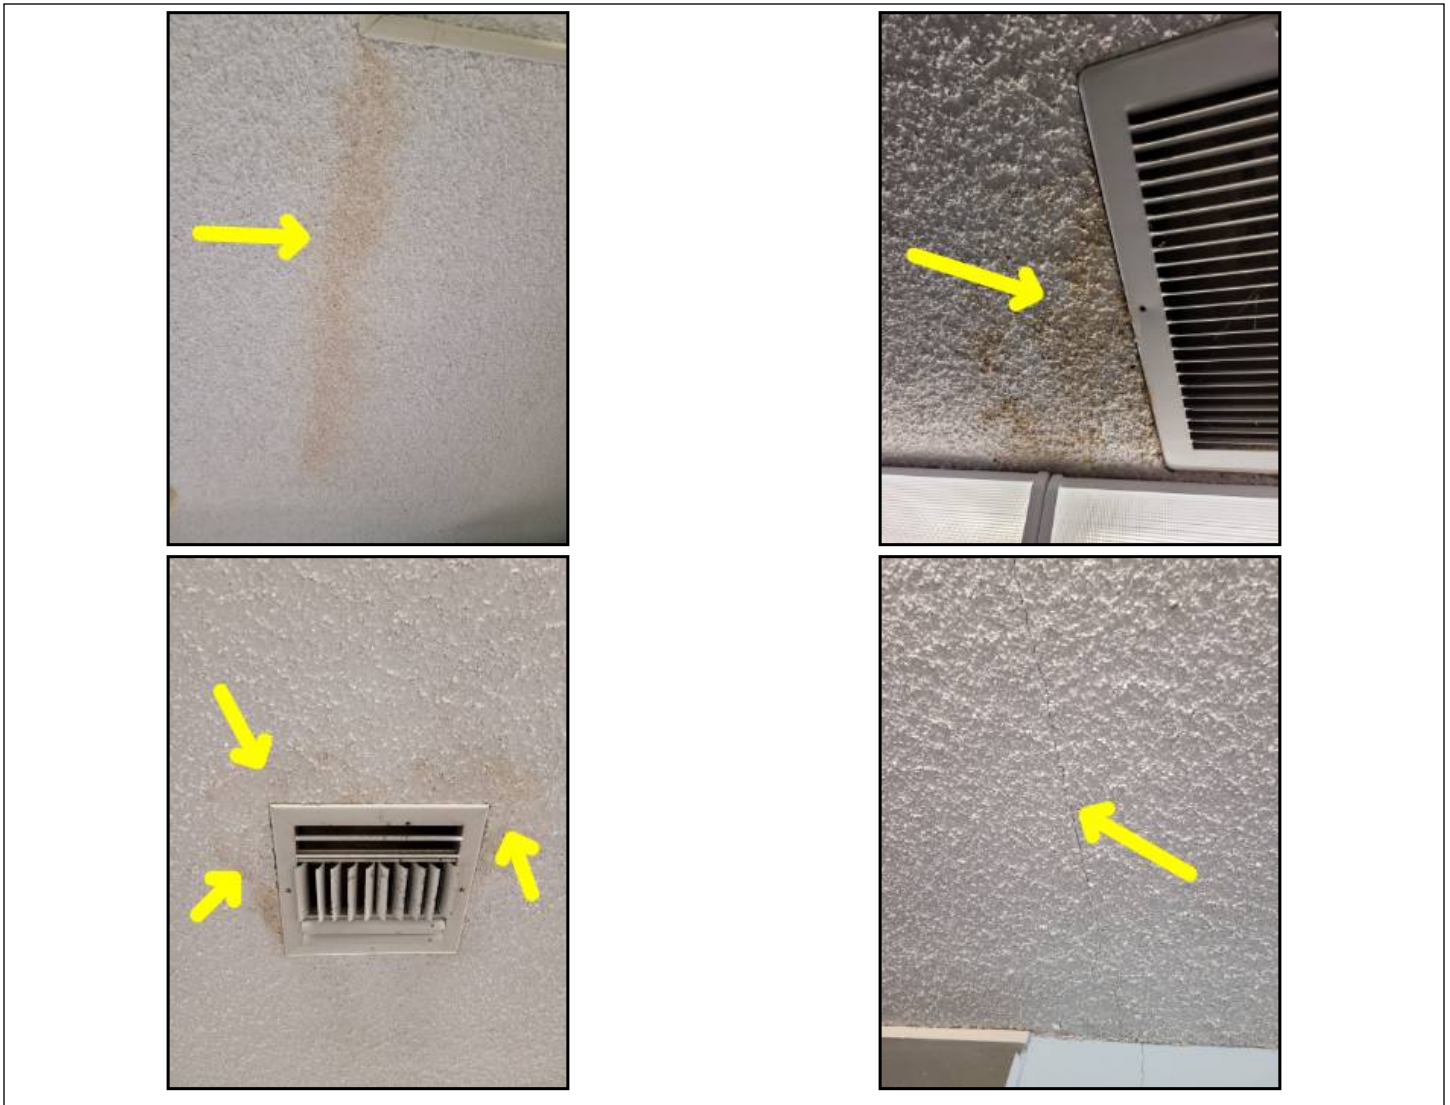
Page 105 Item: 1	Observations	1.2. Limited review of the interior during the time of inspection due to a number of personal items blocking access. Advise verifying condition with a qualified professional as needed.
Page 106 Item: 2	Ceiling Condition	<p>2.1. Acoustic texture, also known as "popcorn", was present at the ceilings. This material was often used from the late 1950s into the 1980s in residential construction. Some of this material installed before the 80's has been known to contain asbestos. It is beyond the scope of this inspection to test for asbestos. The only way to confirm the presence or absence of asbestos is by having a sample of the material tested in a lab. If client has any concerns regarding asbestos materials, an asbestos-testing lab should be consulted for further review.</p> <p>2.2. Evidence of water staining was observed at the second level ceiling in one or more areas. Conditions tested dry with the thermal imaging camera at the time of inspection. Refer to the sellers and sellers disclosure to advise. Monitor conditions.</p>

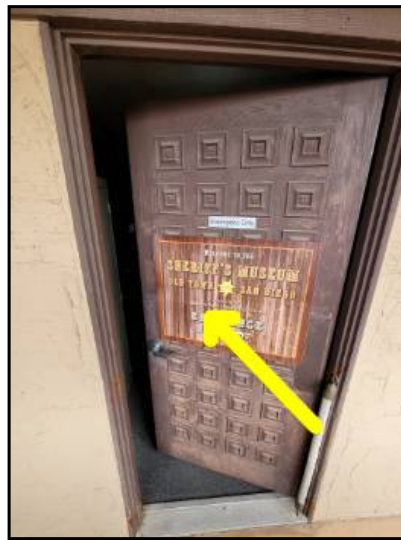
Page 107 Item: 3	Doors	3.2. We recommend the doors to swing outward. Being that this building is a commercial property, all doors should swing outward for proper fire egress and escape. Seek a licensed contractor for further evaluations and repairs.
------------------	-------	--

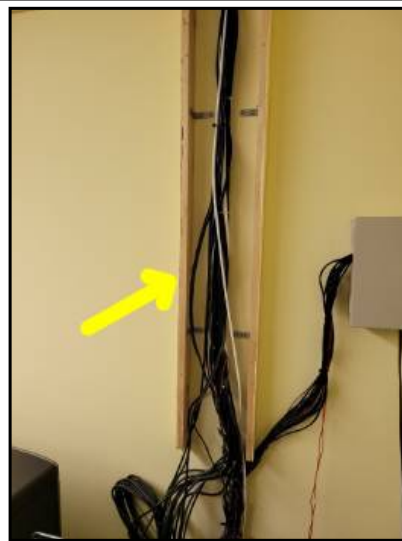
Page 108 Item: 4	Electrical	4.1. There are cover panels to the security system wiring that are missing.
------------------	------------	---

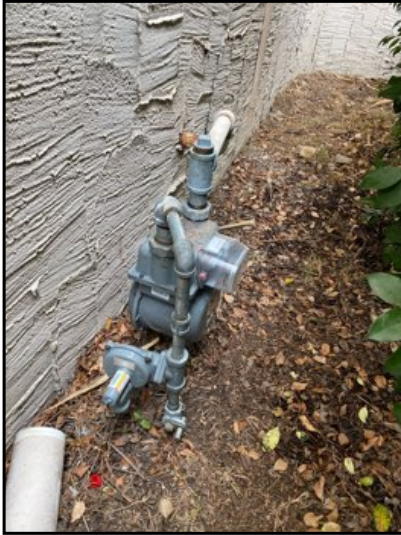
6.1. The gas service is off to the structure. The inspector cannot inspect this system. The main gas shut off valve is located at the gas meter. The unit was off and locked. No gas related items were tested. Advise testing before close of escrow.

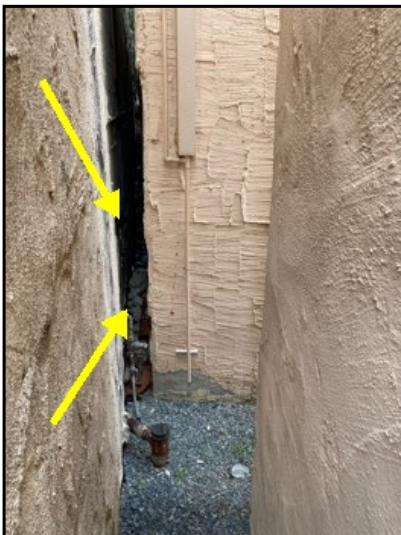
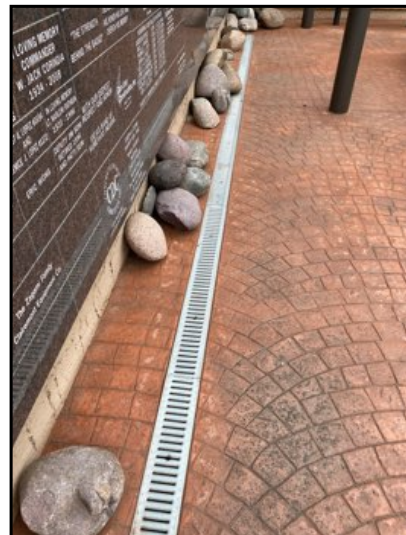
8.4. There is a negative slope/improper storm water drainage at the rear of building and can cause or contribute to water intrusion or deterioration. Recommend further evaluation by a licensed grading and drainage contractor to determine corrections needed at this time.

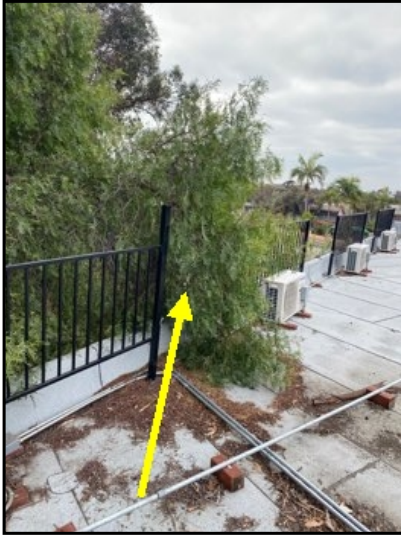
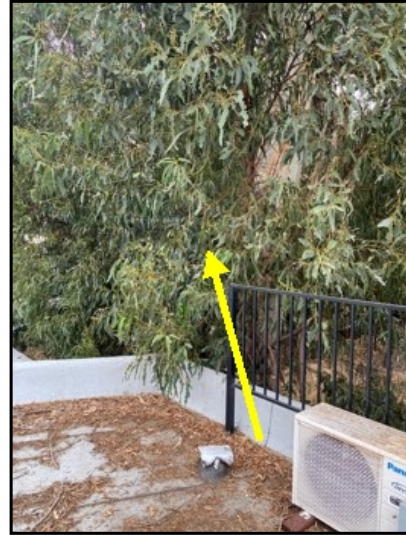
9.1. There are tree branches that are in contact with the roof. Trim trees that are in contact or proximity to home, as branches can abrade roofing or siding and cause damage. Refer to a licensed arborist/tree trimmer for repairs.

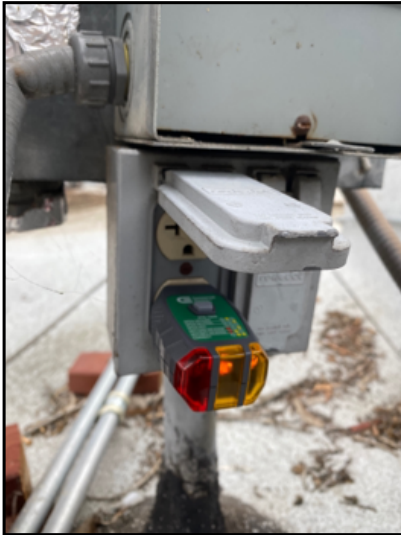
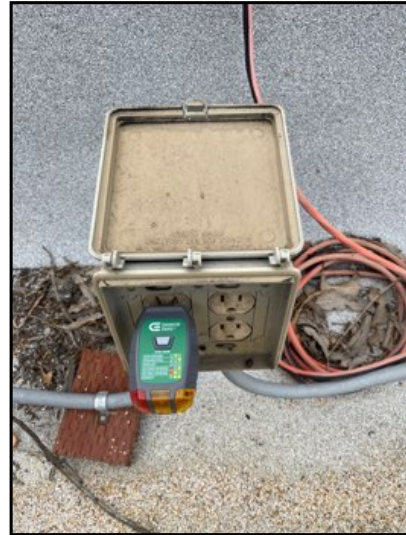
10.1. No Ground Fault Circuit Interrupter (**GFCI**) protection at the exterior electrical outlets was provided in the home at the time of inspection. Although GFCI protection may not have been required at the time the home was built, for safety reasons, consider upgrading the electrical system to include GFCI protection. Caution, conditions poses a potential safety shock hazard. Seek a licensed electrical contractor for further evaluations and repairs.

10.2. The rooftop exterior outlets are not functional and are not GFCI protected.

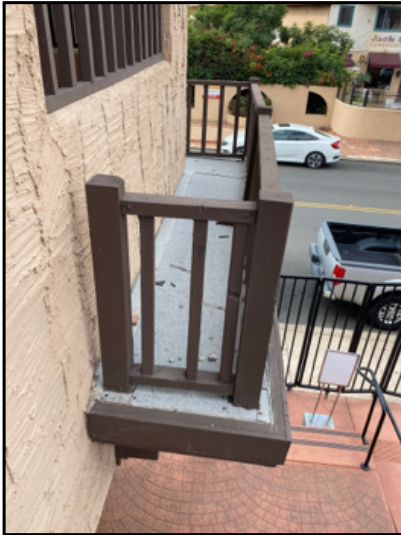
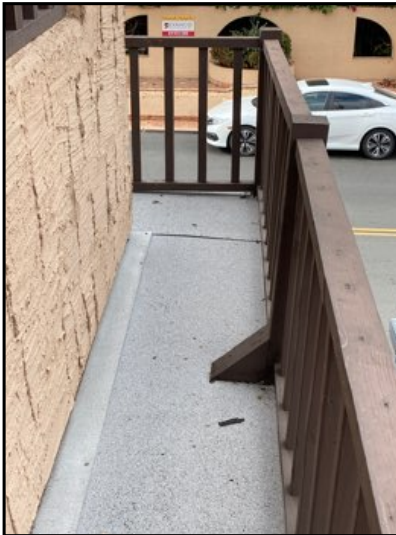
12.1. The balcony structure has a rolled cap sheet roofing material that has been improperly nailed onto the structure in various areas. Advise correction and repairs to prevent moisture intrusion.

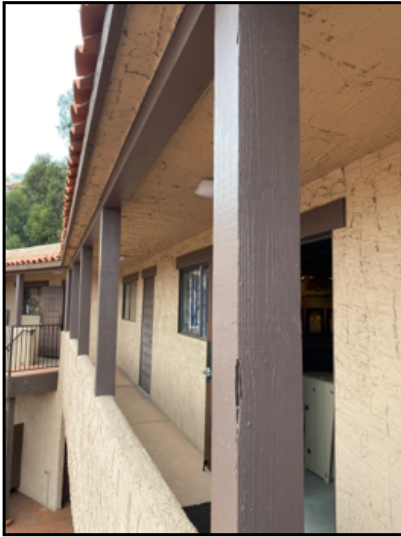
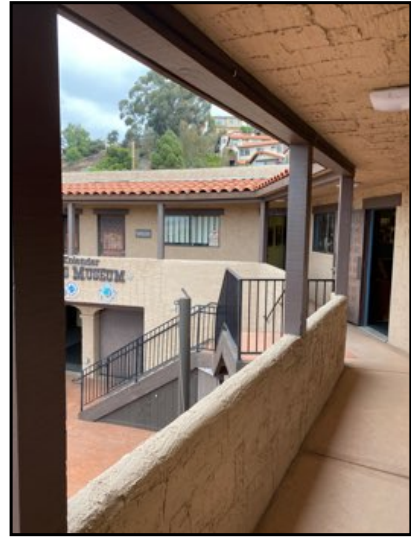
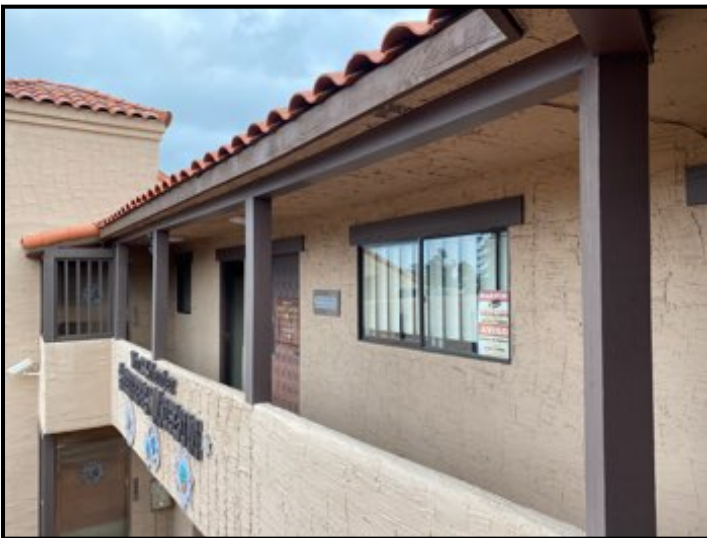
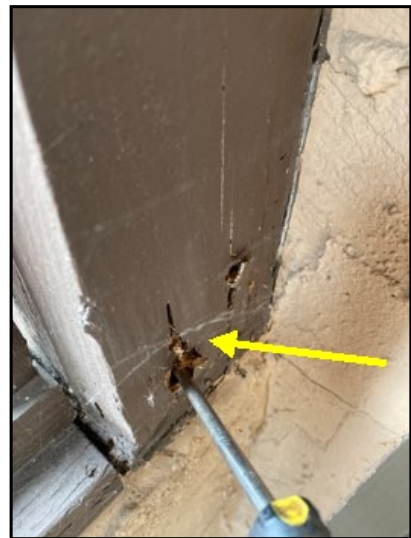
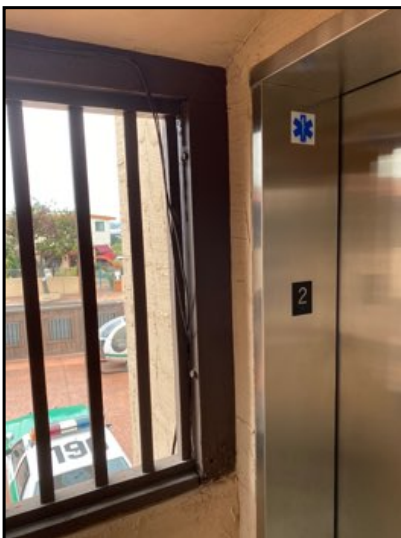
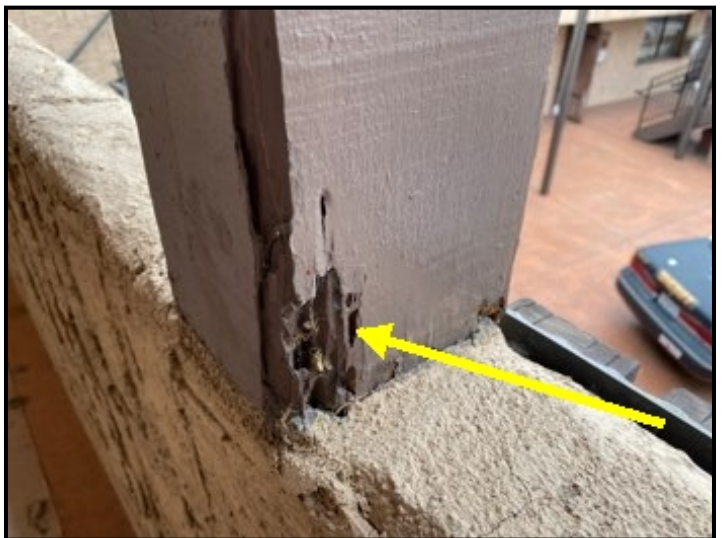
13.1. Dry rot and termite damage noted on the patio roof structures support columns. Seek a qualified licensed termite contractor for repairs and correction.

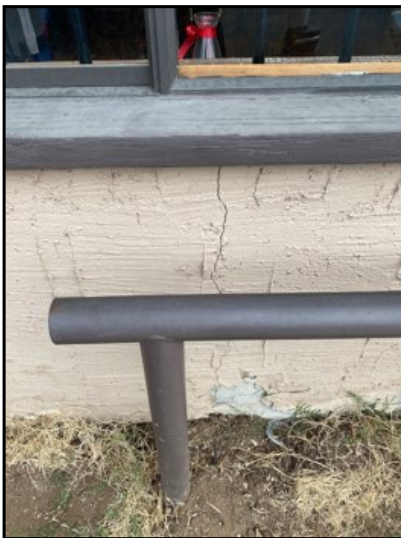
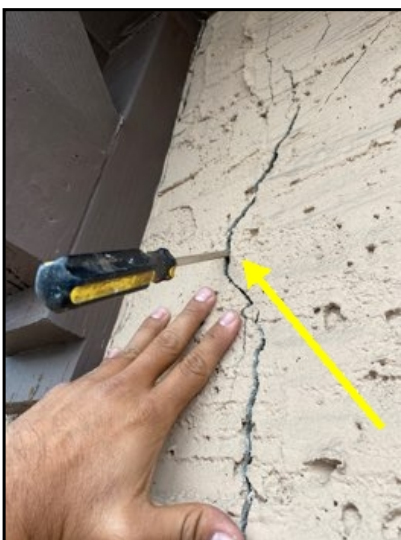
1.1. Cracked and chipped stucco observed in various locations. Seek a qualified licensed contractor for further evaluations and repairs.

1.2. Large cracks observed on the front facing side of the exterior building walls. These cracks could be a result of property settlement and movement to the foundation. The cracks are large enough where you should consult with a licensed foundation specialist and structural engineer for further deterioration to determine the buildings foundation actual condition.

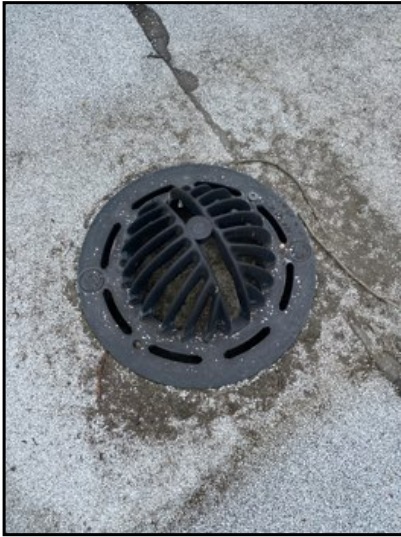
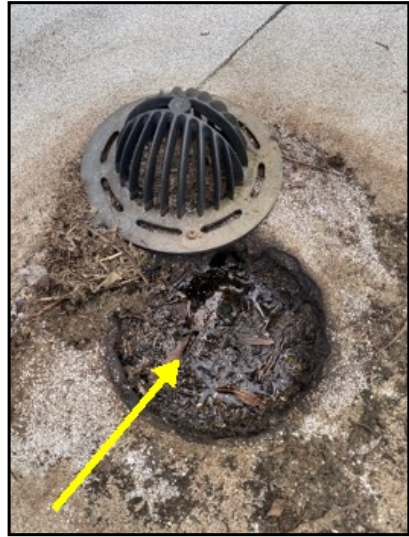
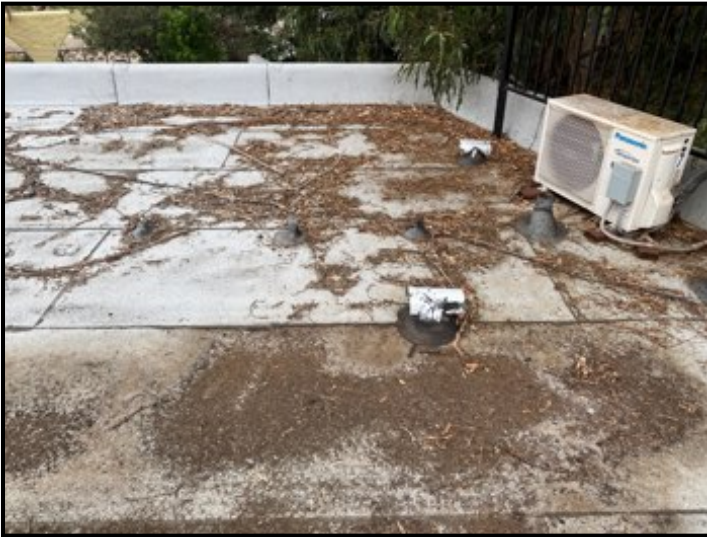
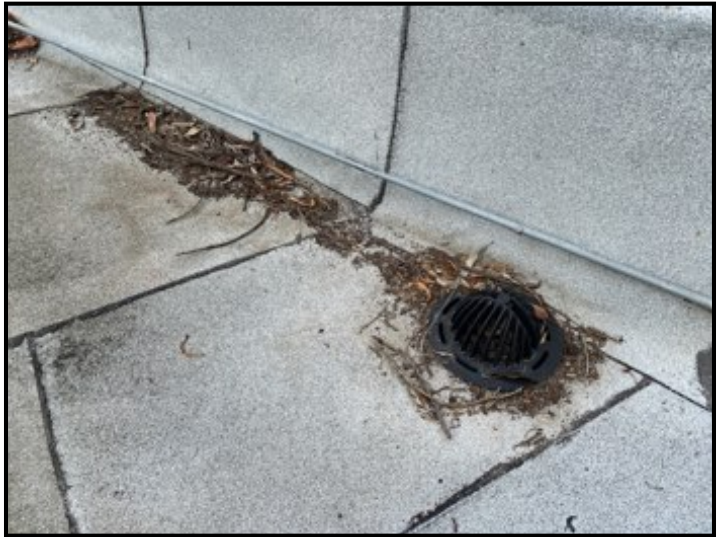
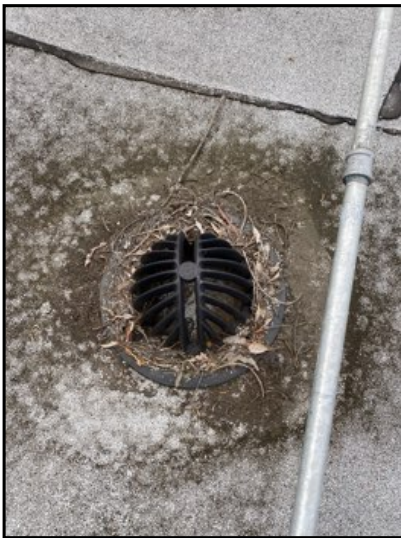
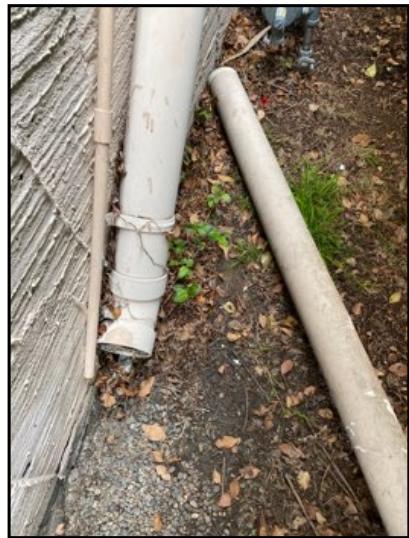
**1.3. The roof drains and roof needs to be serviced and cleaned of all organic debris and sediment. Seek a qualified licensed roofing contractor for repairs and maintenance.**

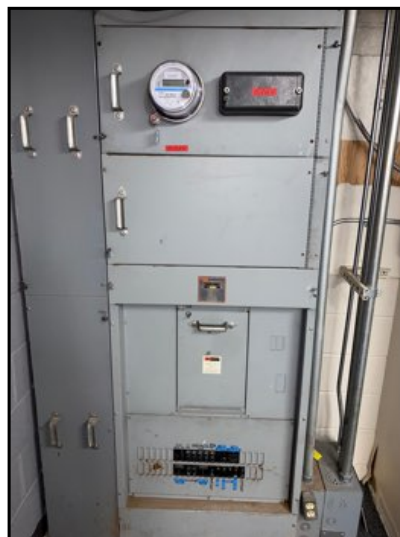
2.2. Recommend installing a proper closet around the meter switch board. It is not enclosed in a closet for safety. Seek a licensed contractor for repairs/correction.

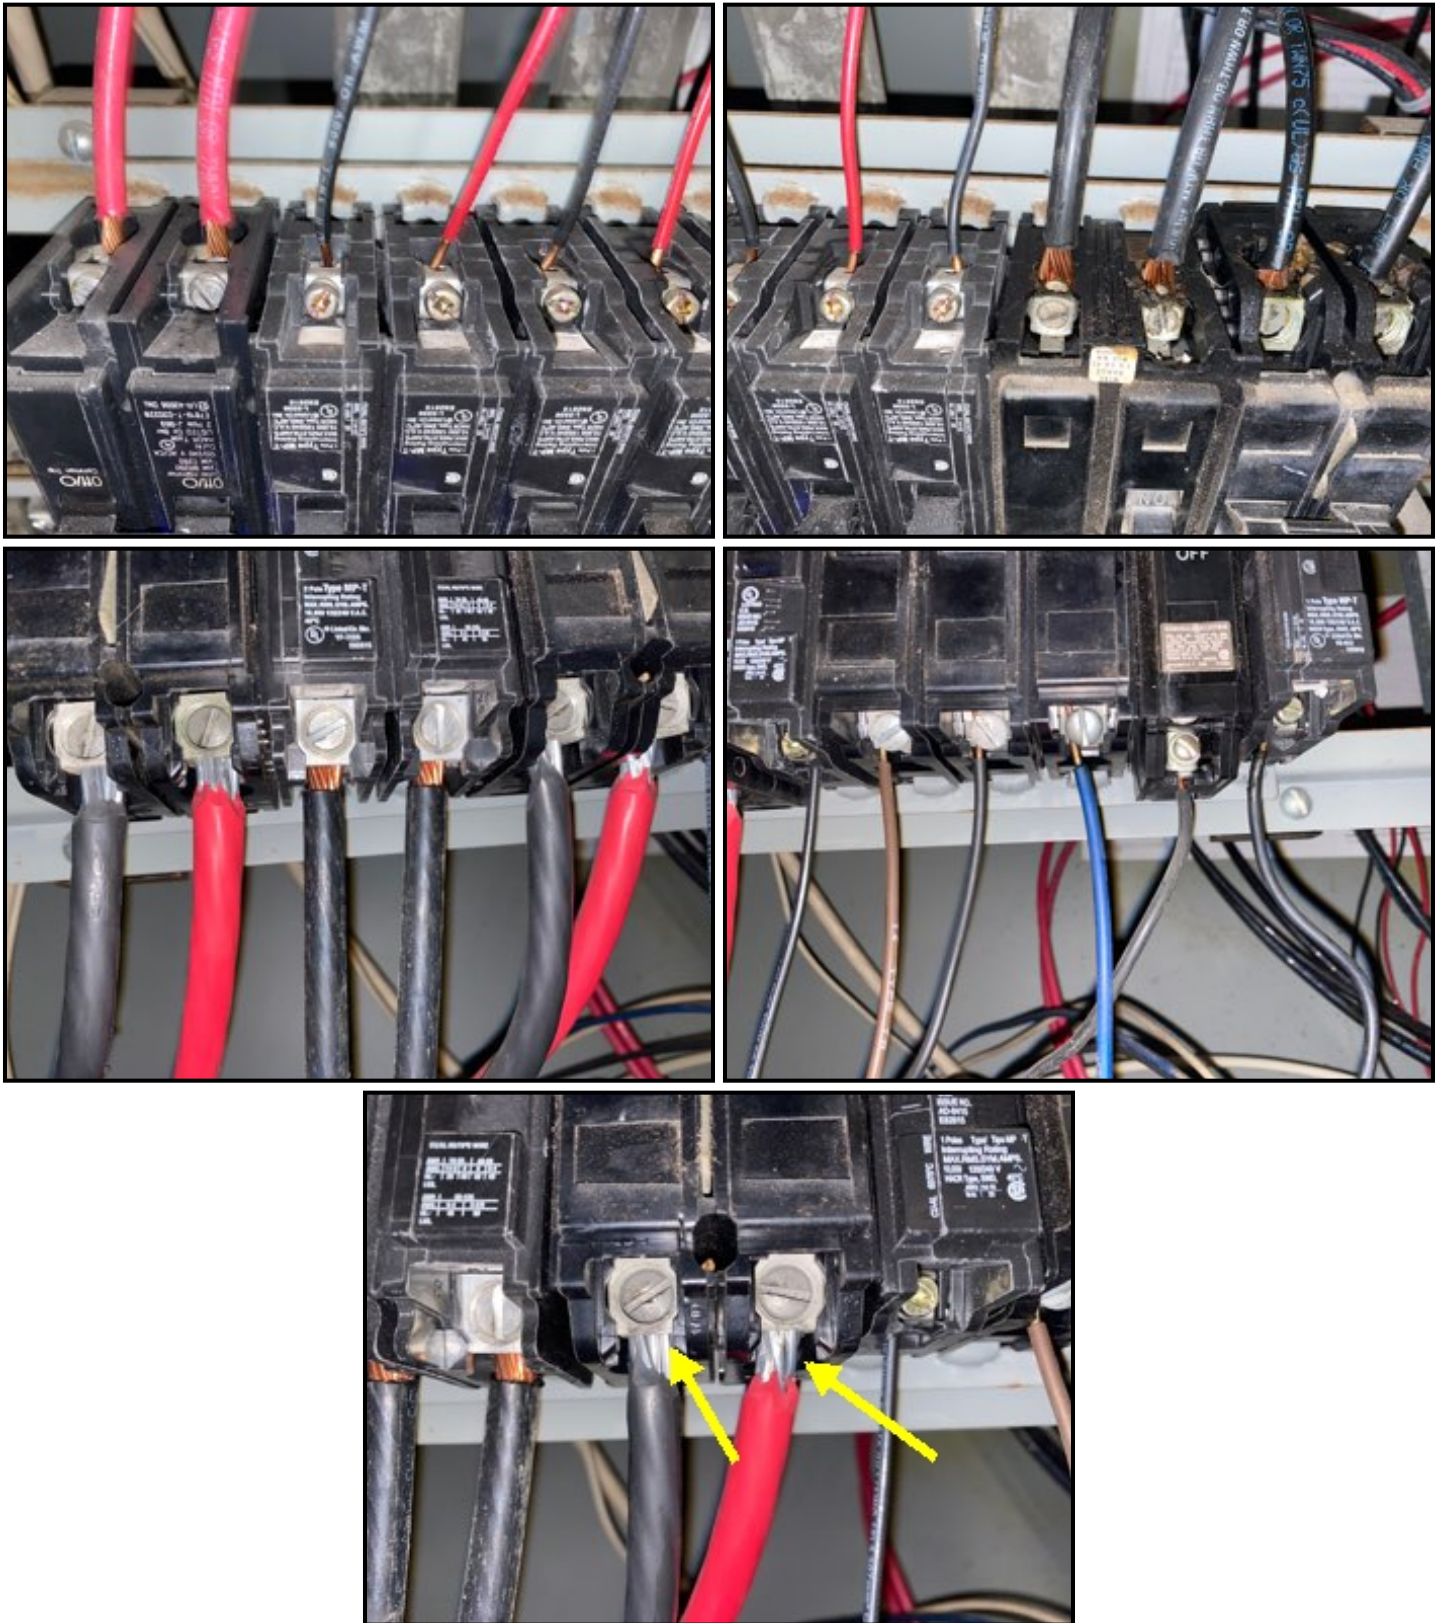
5.2. Recommend applying Aluminum antioxidant paste on the aluminium strand wiring as needed.

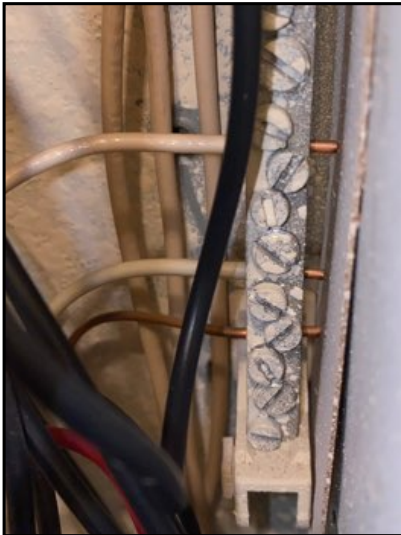
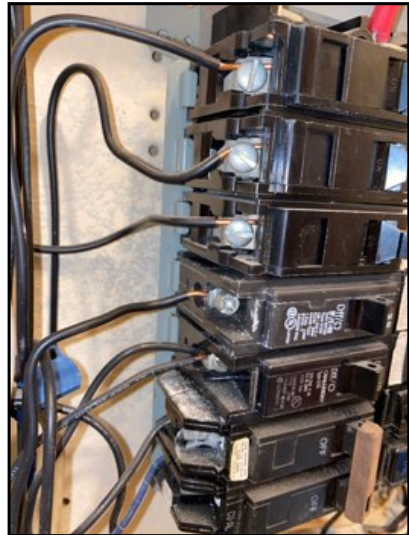
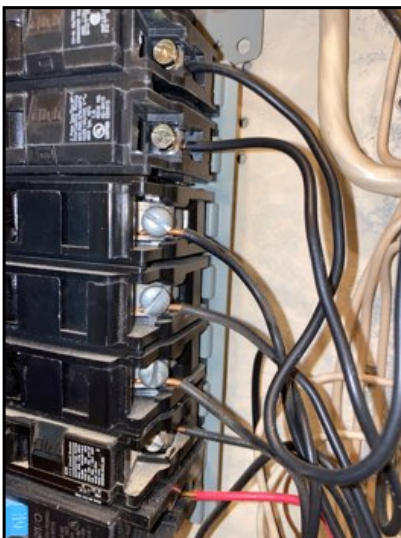
3.1. A single pole 15 amp breaker was observed to be "double tapped" in the sub panel. This does not meet current standards of practice and poses as a potential safety hazard. Seek a qualified licensed electrical contractor for further evaluations and repairs.

3.2. There are neutral and ground wires in the electrical Sub Panel are being shared on the same bus bar. This may be consistent with time of construction but does not appear to meet current standards of practice and may pose a potential safety hazard. Seek a licensed electrical contractor for further evaluations and repairs.

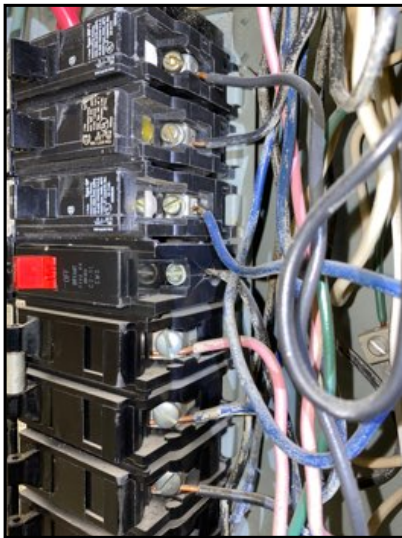
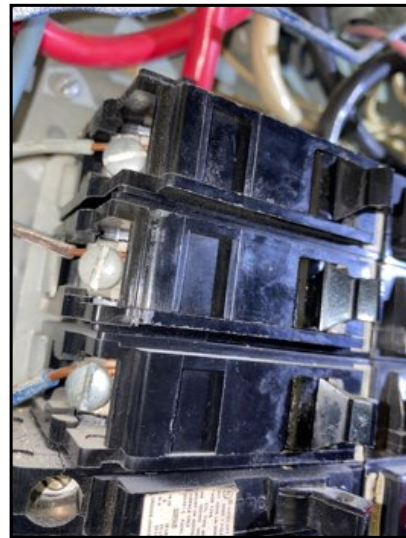
3.2. Two single pole 20 amp breakers are "double tapped" in the sub panel. This does not meet current standards of practice and poses as a potential safety hazard. Seek a qualified licensed electrical contractor for further evaluations and repairs.

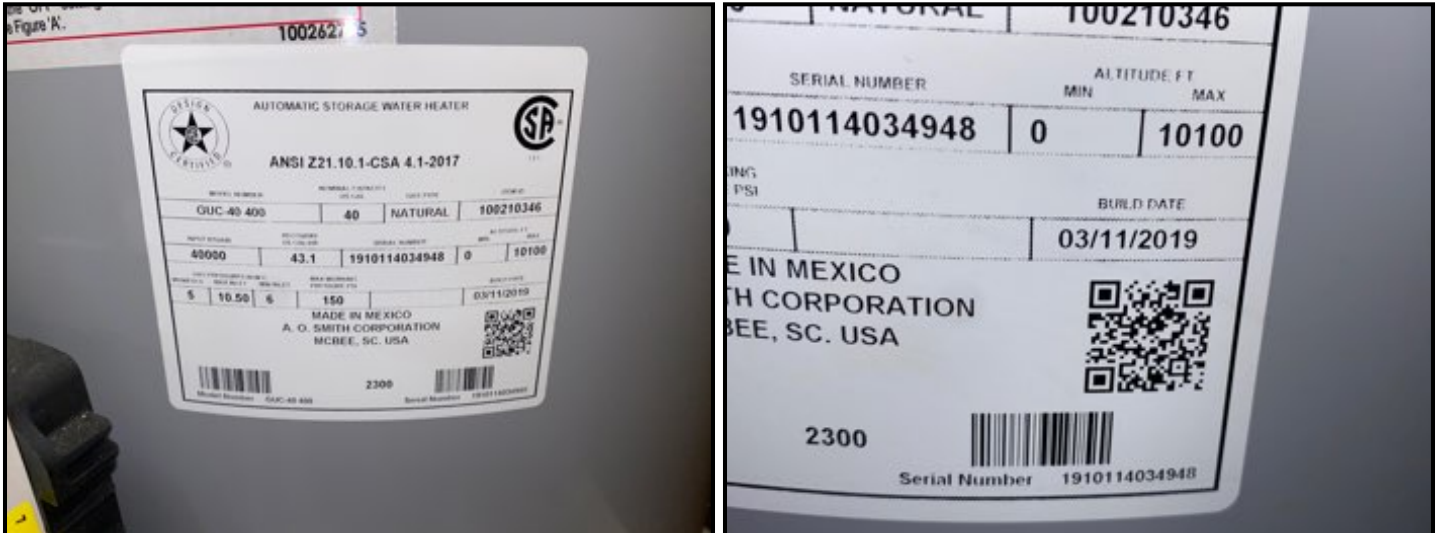
2.1. The water heater could not be fully evaluated or turned on at the time of inspection. The gas meter was shut off to the building. Refer to San Diego Gas and Electric to turn on the gas and reinspect the appliance.

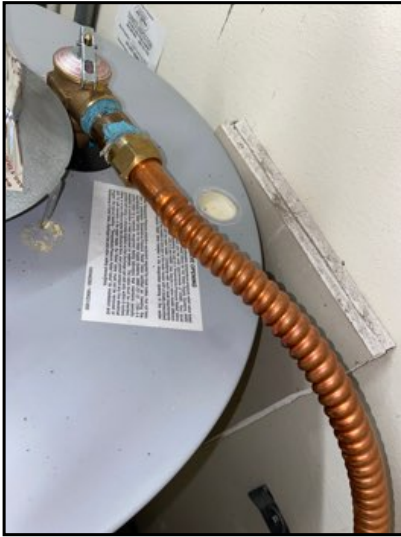
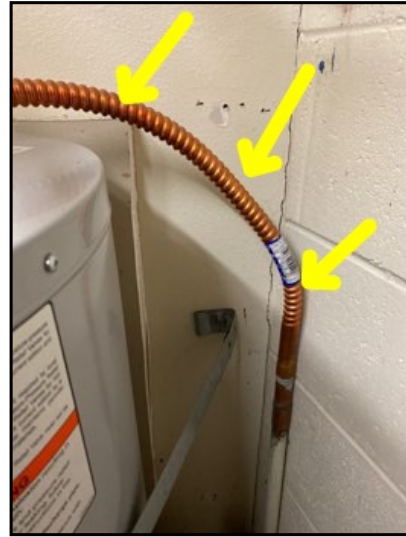
5.2. **CAUTION:** The temperature relieve valves discharge pipe appears to be a threaded flexible type which does not meet current standards of practice. This is a potential safety hazard. Seek further evaluations by a licensed plumbing contractor.
