# Property Inspection Report

2384 San Diego Ave , San Diego , CA 92110  
Inspection prepared for: Rachel Parrott  
Date of Inspection: 11/23/2020 Time: 8:30 AM  
Age of Home: 1972 Size: 6888 Sqft  
Weather: Clear

Inspector: Eric Martinez  
NACHI12100924  
2122 W Mission Rd, Escondido, CA 92029  
Phone: 619-501-8282  
Email: emartinez@theinspectorscompany.com

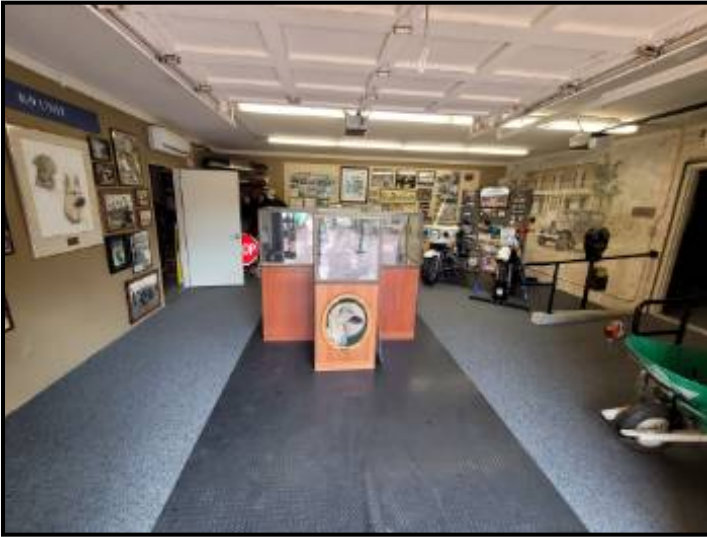
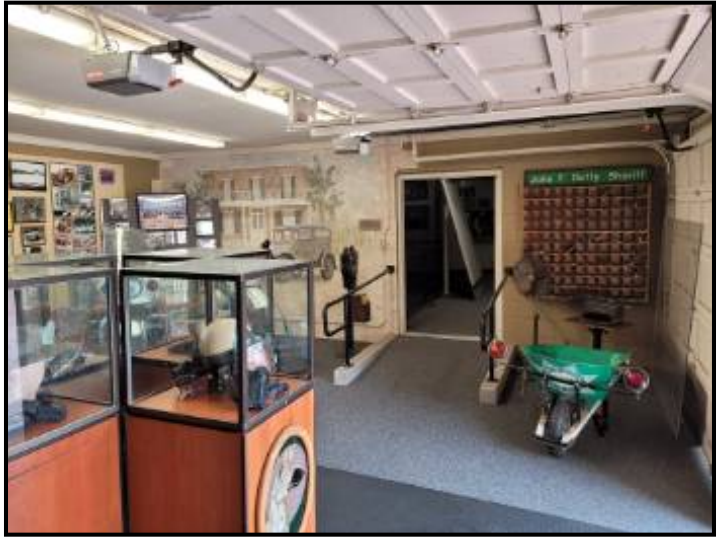
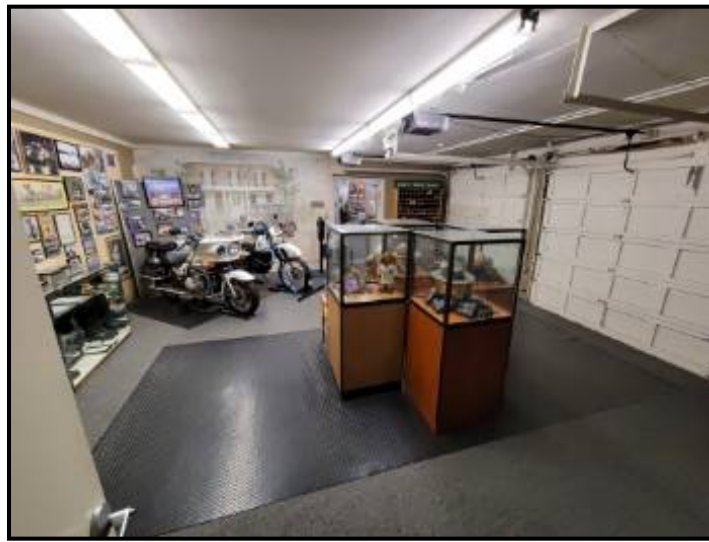
2.1. The large door to the lower interior area is not fully self-closing and is required to be, to maintain the necessary firewall separation between a garage and living quarters, and will need to be serviced. Caution potential fire and safety hazard. Refer to a licensed contractor for approved repairs.

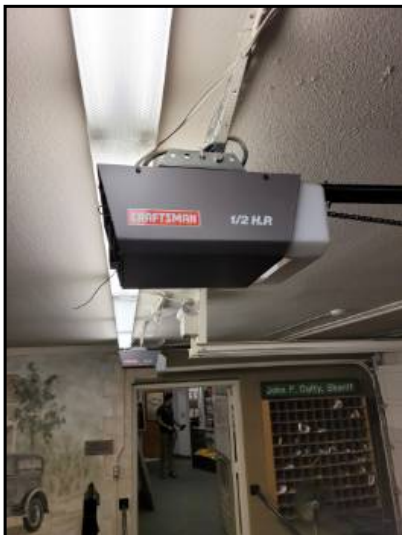
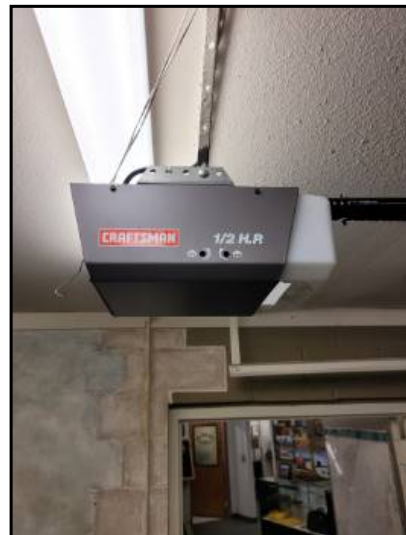
3.1. The garage door opener and its components were functional at the time of inspection.

3.2. Light bulbs are blown on both garage door openers.

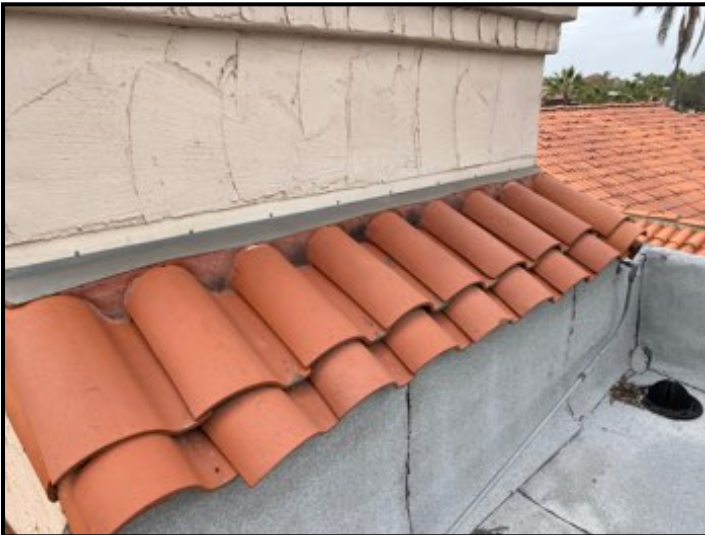
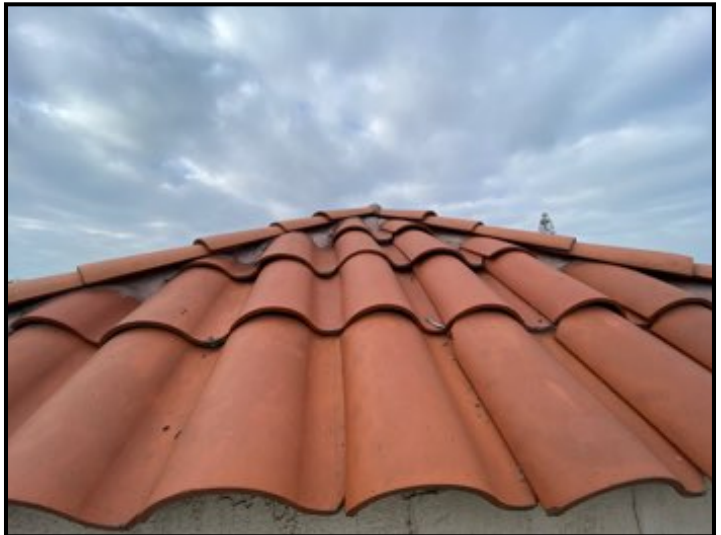
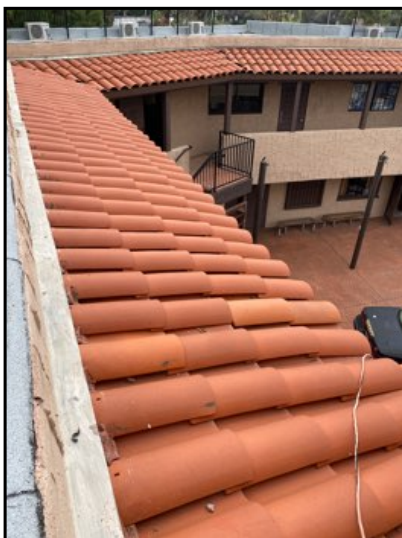
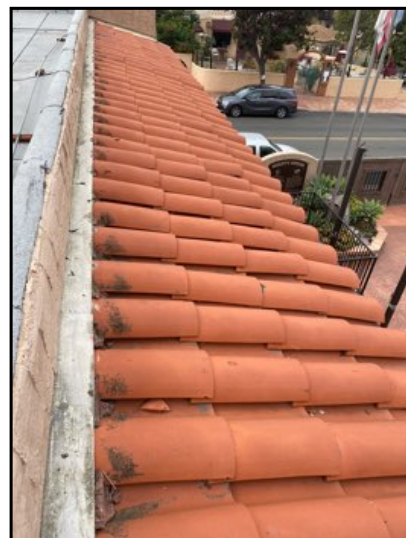
1.1. The roof is in acceptable condition, but this is not a guarantee against leaks. For a guarantee, you would need to have a roofing company perform a water-test and issue a roof certification.

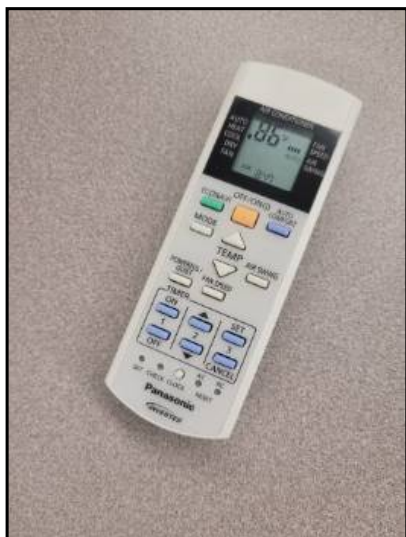
Located in break room

2.1. There are 2 main control thermostat remotes. One is located in the southside upstairs office and one in the northside office. Both are functional at the time of inspection.

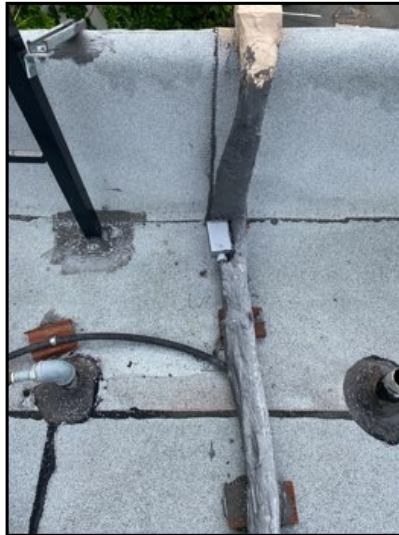
4.1. The visible portion of the refrigerant lines appeared to be in acceptable condition.

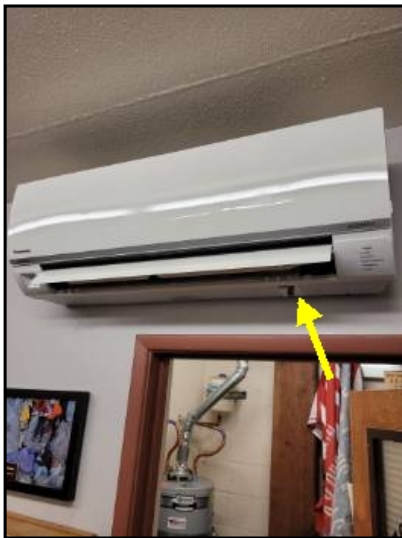
1.1. The number 7 Heat and AC mini split blows air, but heat and cool function did not work at the time of inspection. Seek a licenced HVAC technician for further evaluation and repairs.

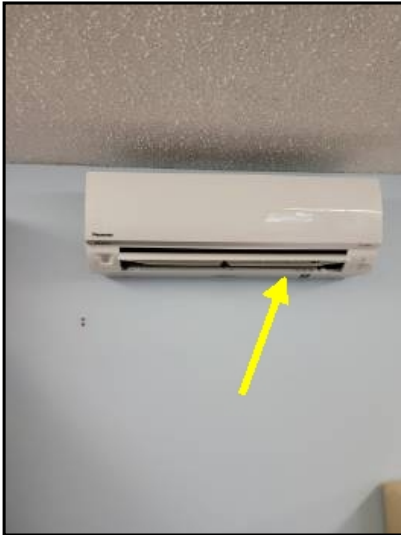
1.1. The #9 Heat and AC mini split blows air at the time of inspection, but the heat and cool function did not operate. Seek a licensed HVAC technician for further evaluation and repairs.

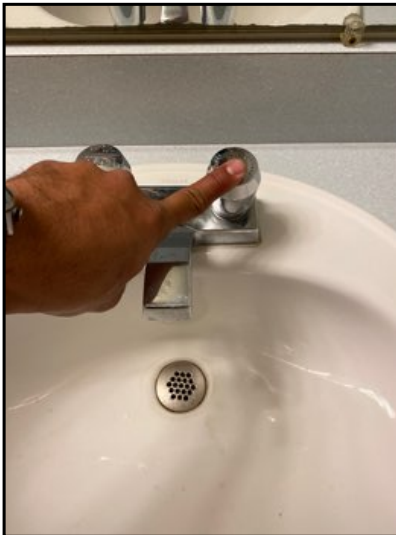
2.1. Right side cold water control handle does not shut off. The water shut off valve has to be turned off.

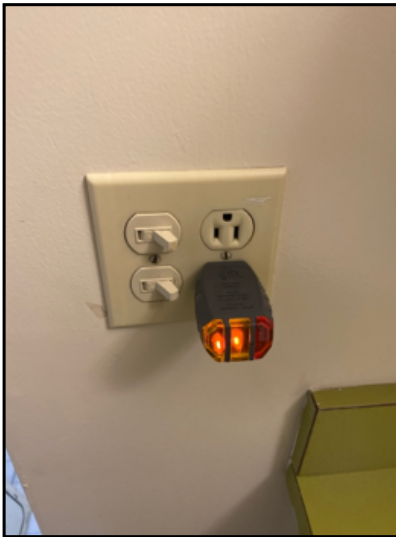
2.1. Bathroom counter top outlets should be upgraded to have ground fault protection, which is mandated by current standards and is an important safety feature. Caution, potential safety shock hazard. Seek a licensed electrical contractor for repairs.

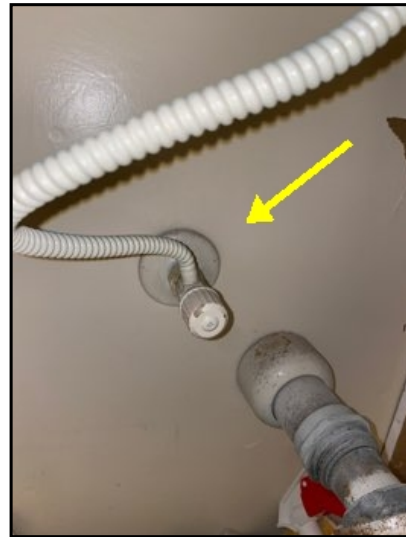
5.2. Older style water shut off valves and/or supply lines noted. Buyer is cautioned that these traps can leak at any time due to corrosion. Seek a qualified licensed plumbing contractor for repairs and replacement.

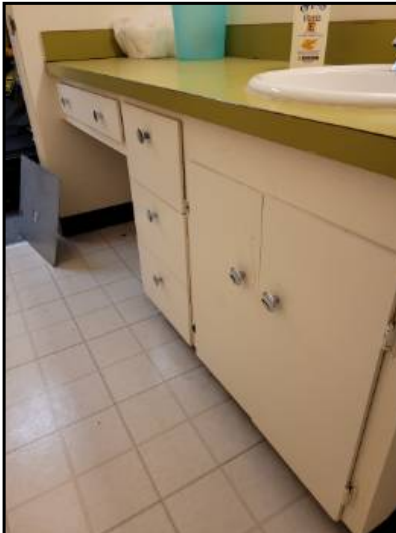
3.1. The counter tops appear to be worn and damaged. Seek a licensed contractor for repairs.

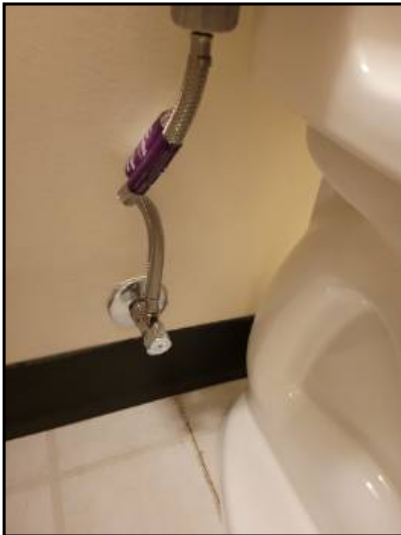
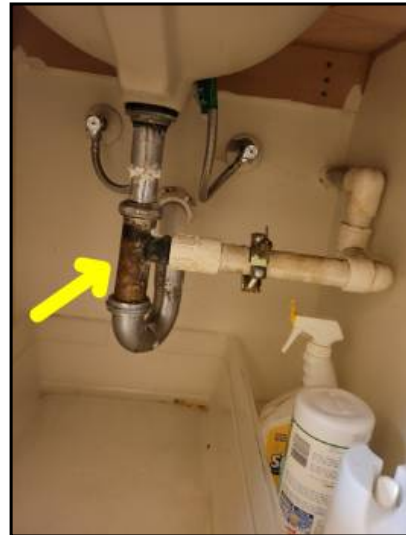
5.2. The bathrooms waste pipes were observed with signs of corrosion/build up at the fittings. This is susceptible to water leaks and moisture intrusion. Refer to a licensed plumbing contractor for repairs.

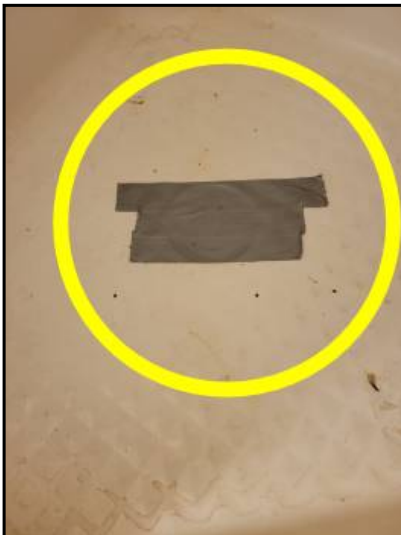
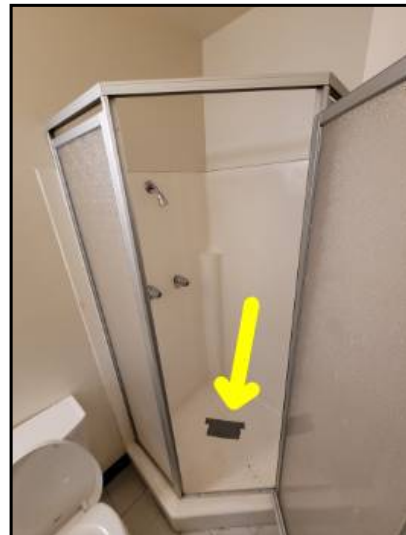
6.1. The bathroom shower actively drips when in operation. Seek a licensed plumbing contractor for repairs.

6.2. The shower drain was duct taped over at initial time of inspection. We peeled it back and checked the shower drainage. The shower drained adequately at the time of inspection. Refer to sellers for information pertaining to the taped drain.

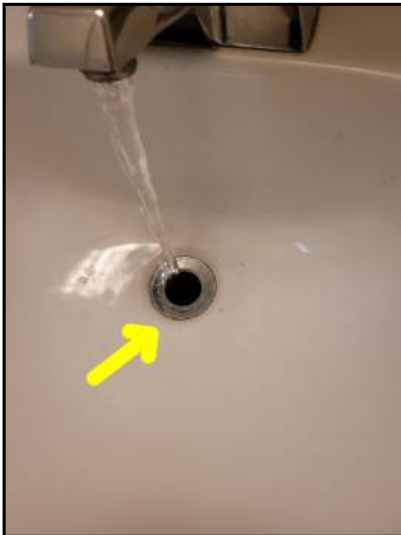
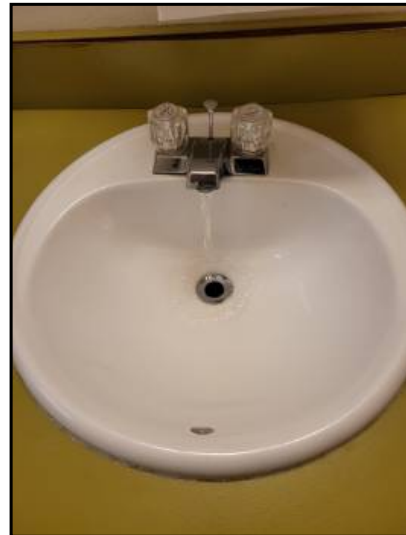
7.1. The bathroom sink stopper was observed missing/inoperable. Seek a licensed plumbing contractor for repairs.

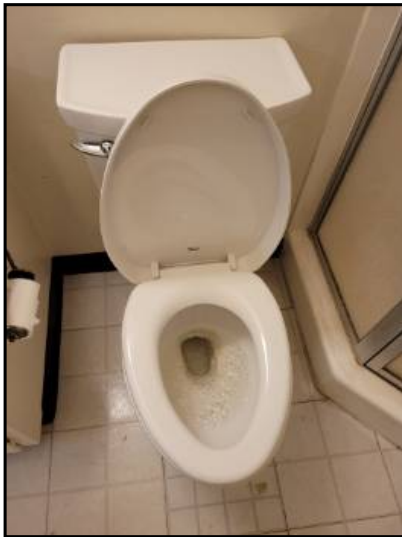
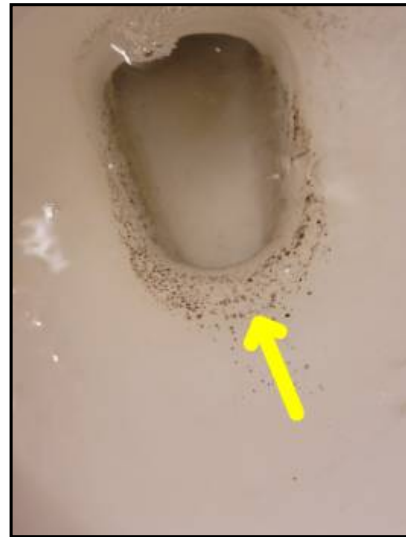
8.1. Signs of mold like substance observed in the toilet. This could be due to lack of use.

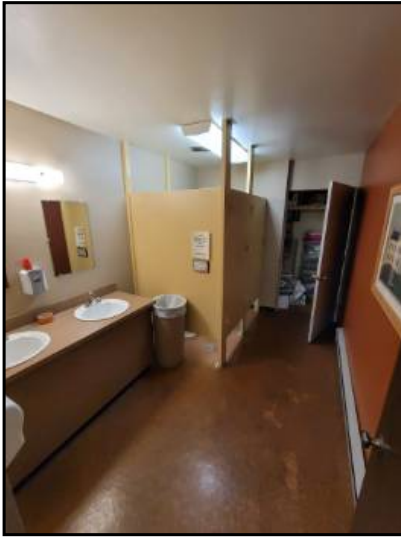
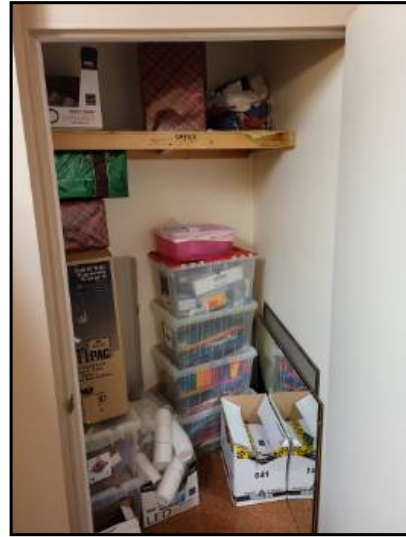
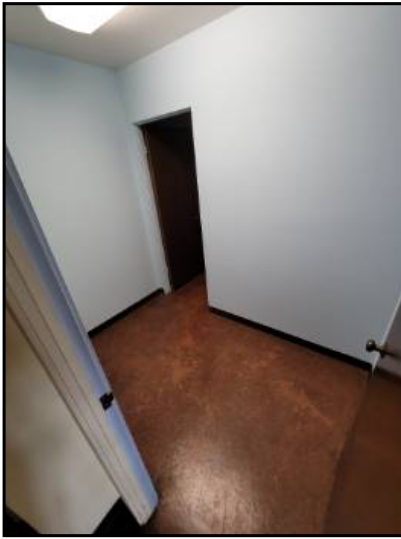
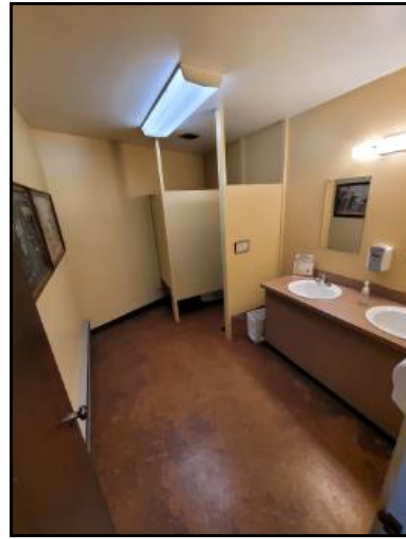
2.1. The counters should pedestal style sinks so that a person in a wheelchair is capable of sink use. Per commercial standards at least one sink must be capable for a handicapped accessibility. The front cover board of the sink area restricts wheelchair access. Seek a licensed contractor for further evaluations and repairs.

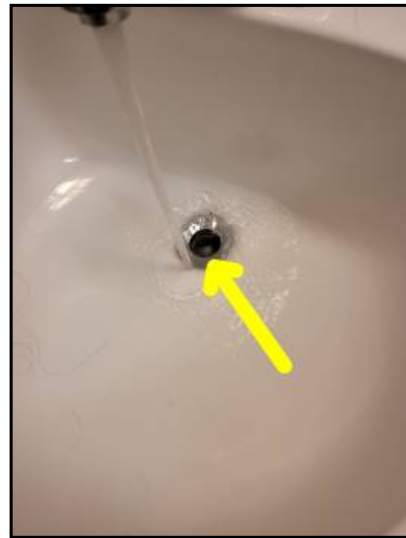
6.1. One or more sink stopper was observed missing/inoperable. Seek a licensed plumbing contractor for repairs.

6.2. Sink has a slow drain at one or more sink drain line. The sink drain appears to be partially blocked and should be serviced. This may be indicative of hair or debris obstructing the sink drain. Refer to a licensed plumbing contractor for further evaluations and repairs.

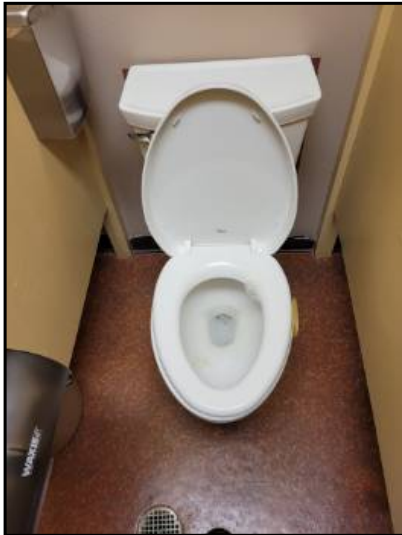
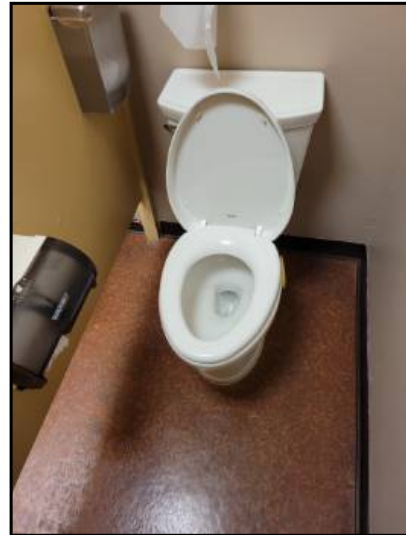
7.1. Toilets are functional and in good visual condition.

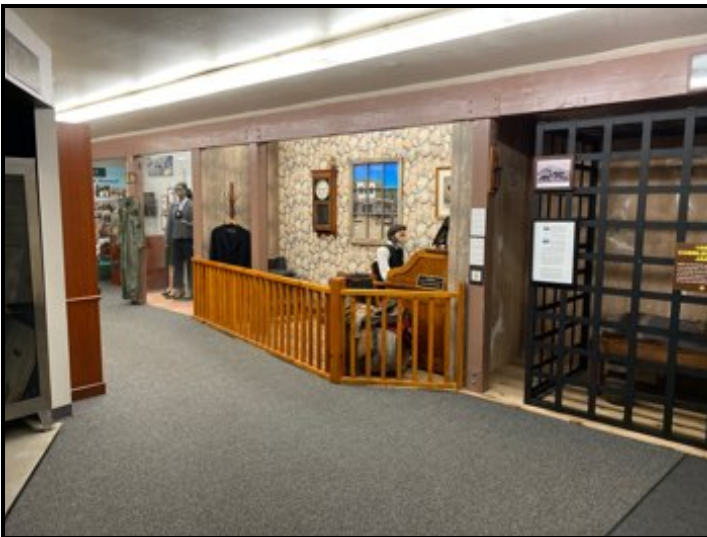
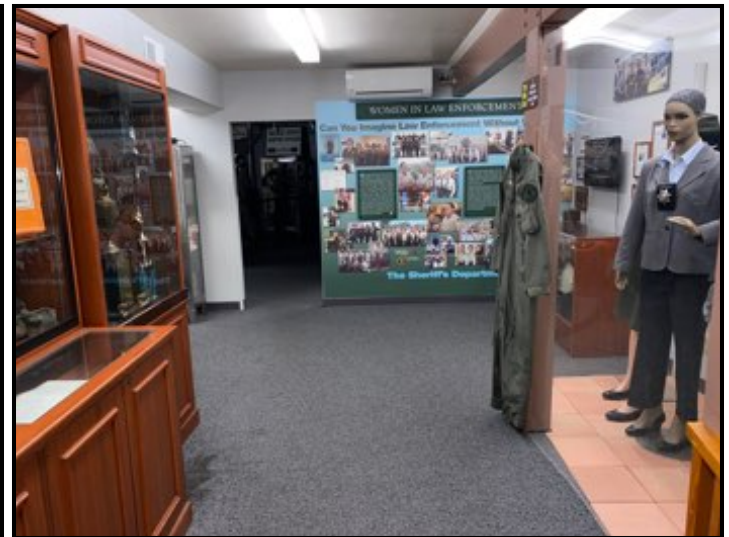
1.1. The general condition of the interior floor, walls, ceiling, windows, outlets are functional and in satisfactory condition.

1.2. Limited review of the interior during the time of inspection due to a number of personal items blocking access. Advise verifying condition with a qualified professional as needed.

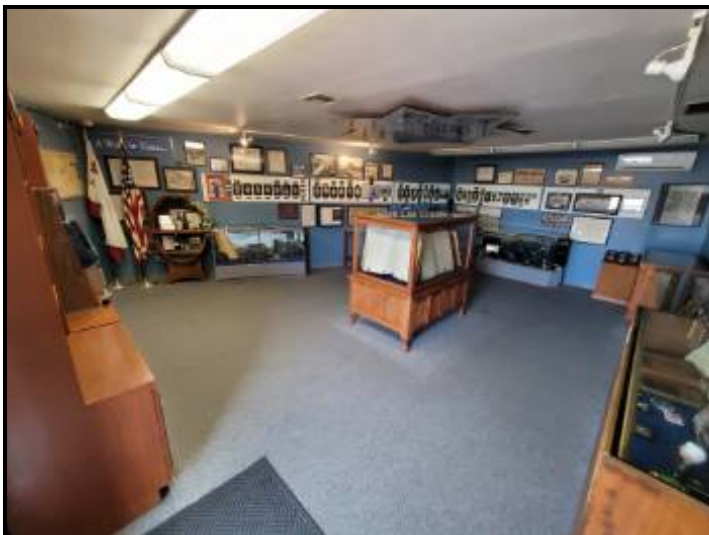
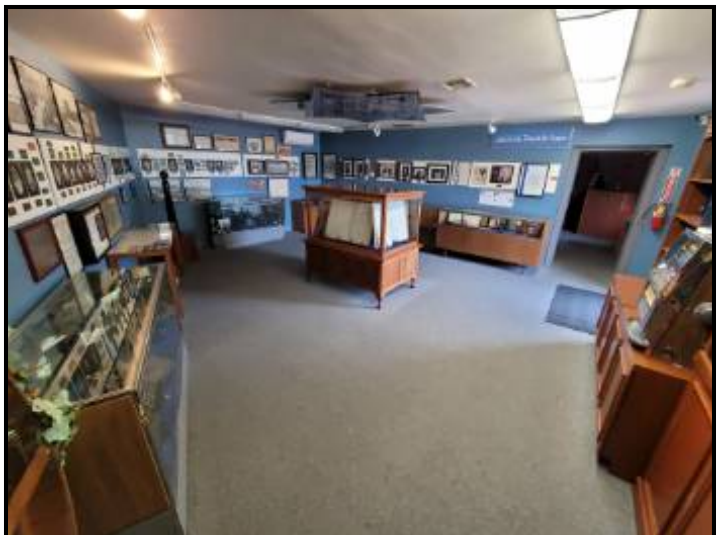
1.1. The general condition of the interior floor, walls, ceiling, windows, outlets are functional and in satisfactory condition.

1.2. The exit signs should be illuminated for easy spotting.

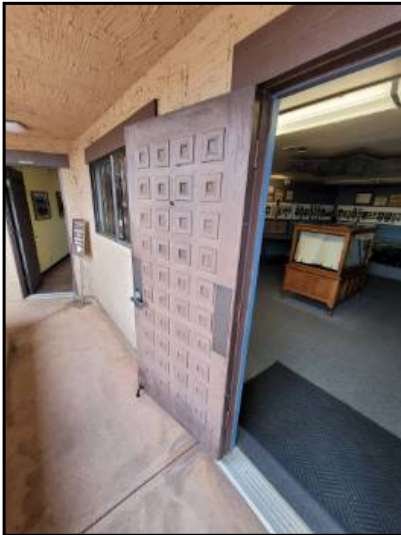
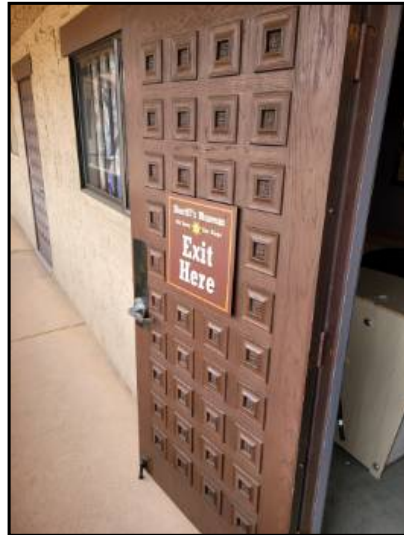
2.1. The main entry door was functional.

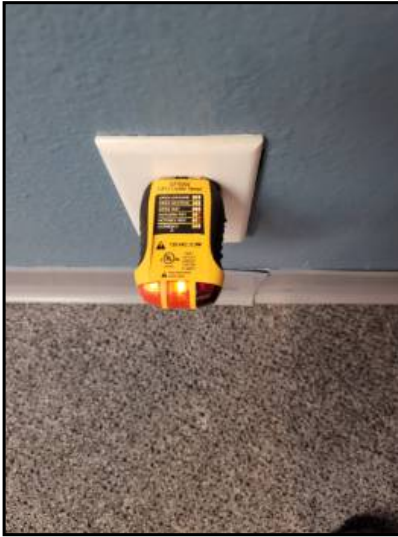
3.1. The outlets that were tested are functional.

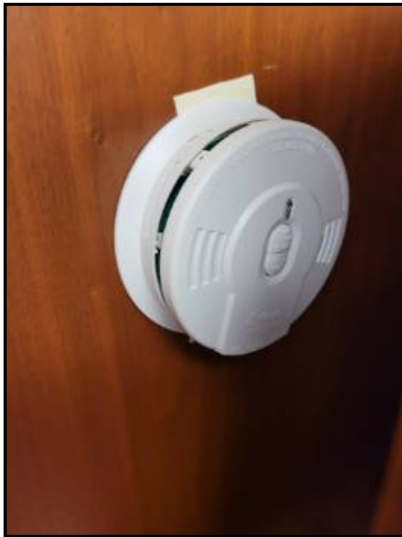
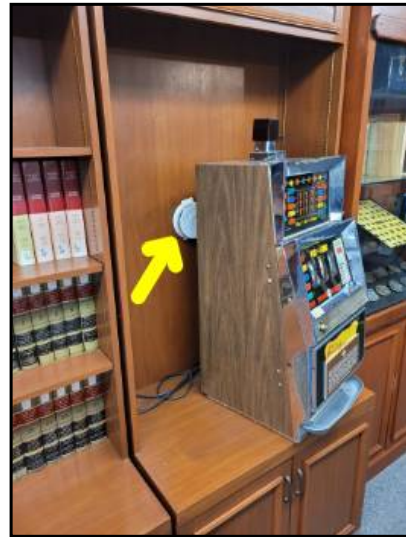
4.1. Smoke detector is present during time of inspection.

4.2. Some of the interior smoke detectors appear to be older (10+years old). According to the National Fire Protection Agency, smoke detectors should be replaced every ten years. Recommend replacing all original smoke detectors.

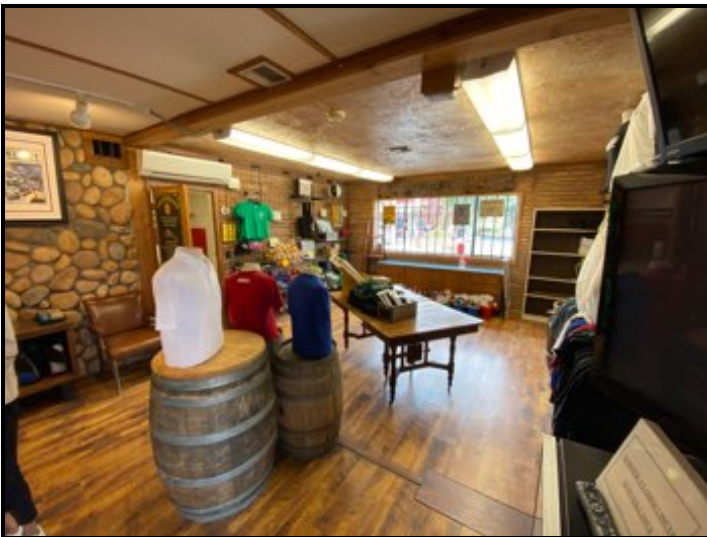
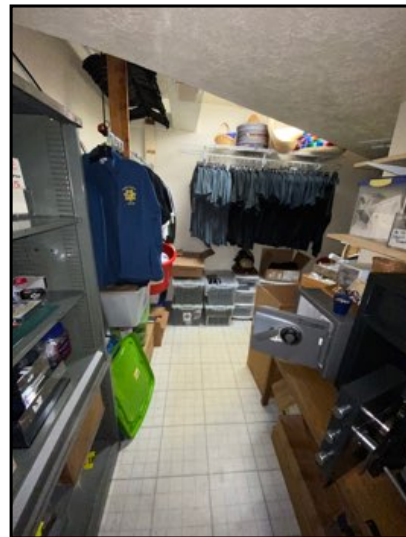
1.1. The general condition of the interior floor, walls, ceiling, windows, outlets are functional and in satisfactory condition.

1.2. Limited review of the interior during the time of inspection due to a number of personal items blocking access. Advise verifying condition with a qualified professional as needed.

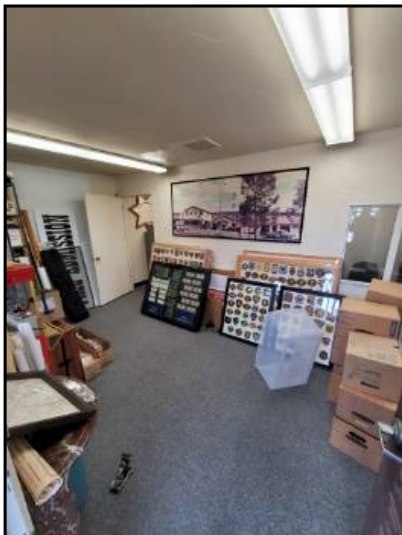
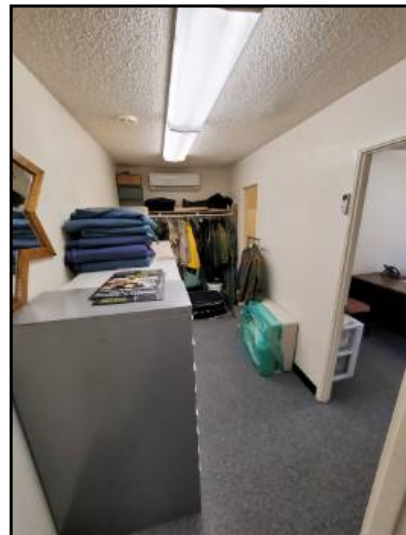
1.1. The general condition of the interior floor, walls, ceiling, windows, outlets are functional and in satisfactory condition.

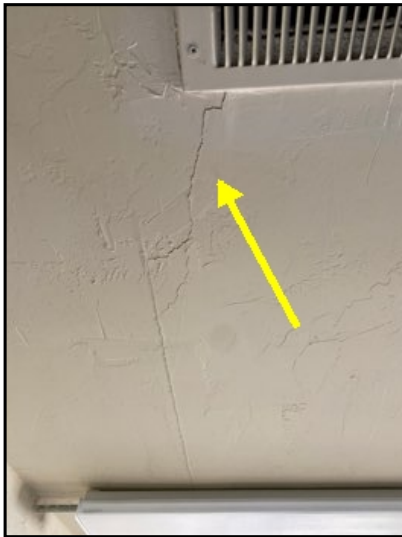
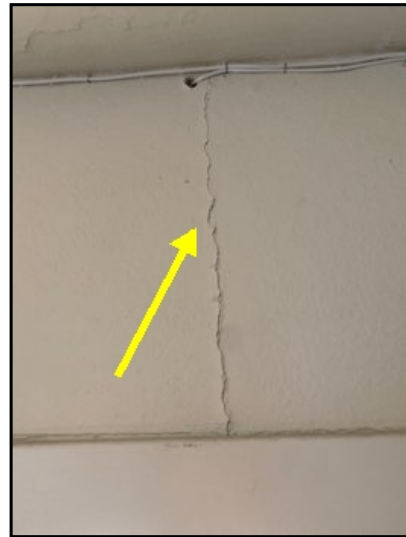
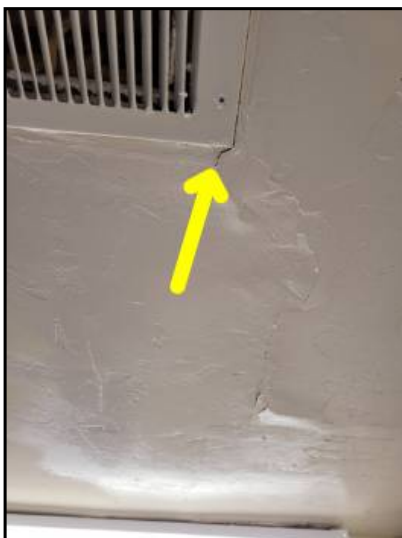
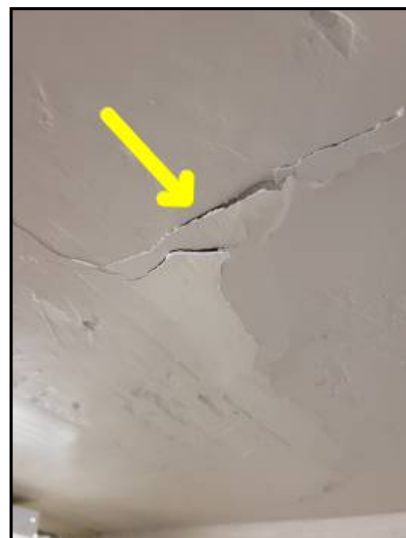
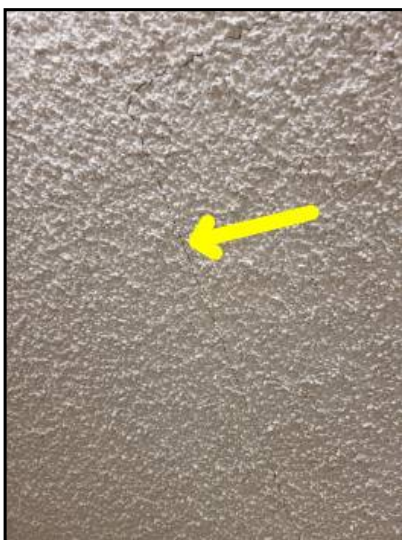
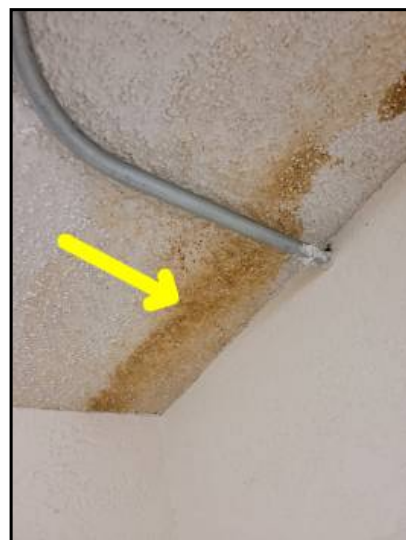
2.2. Evidence of water staining was observed at the second level ceiling in one or more areas. Conditions tested dry with the thermal imaging camera at the time of inspection. Refer to the sellers and sellers disclosure to advise. Monitor conditions.

2.3. The ceilings appear to have typical stress fractures. You may wish to have this further evaluated by a qualified expert and repair as needed.

2.4. There appeared to be evidence of a repair noted on the ceiling in one or more location.

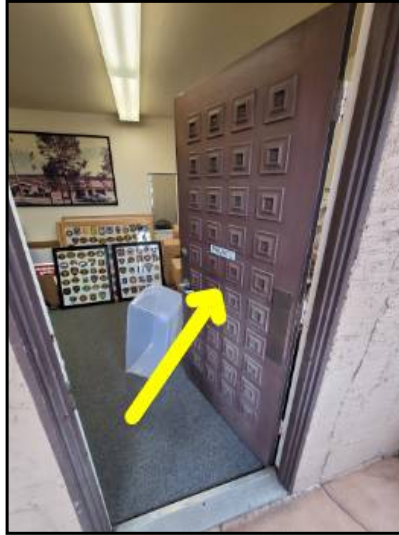
3.1. We recommend the doors to swing outward. Being that this building is a commercial property, all doors should swing outward for proper fire egress and escape. Seek a licensed contractor for further evaluations and repairs.

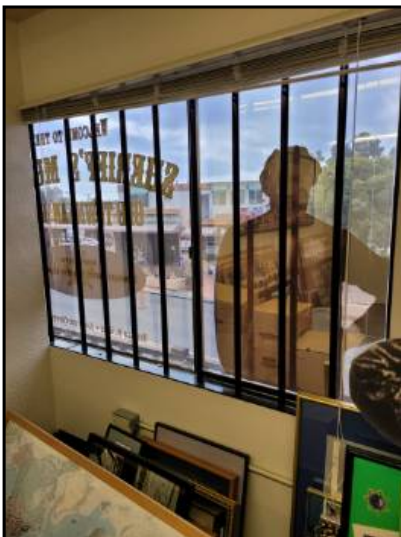
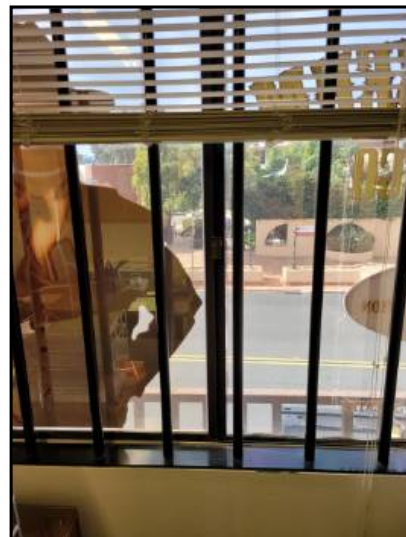
4.1. Glass in homes and buildings built prior to 1977 is likely to be standard plate glass and NOT safety glass. Today, safety glass is required in locations where it is likely to incur impact such as at sliding glass doors, swinging doors, adjacent to swinging doors, at landings, and windows with a bottom edge within 18 inches from the floor. Standard glass has been responsible for numerous injuries and even death. You should upgrade all glass subject to human impact with safety glass.

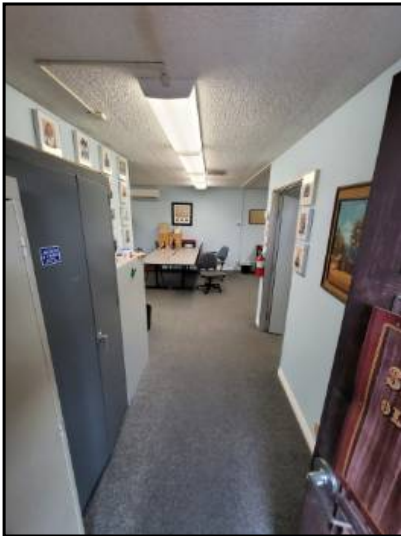
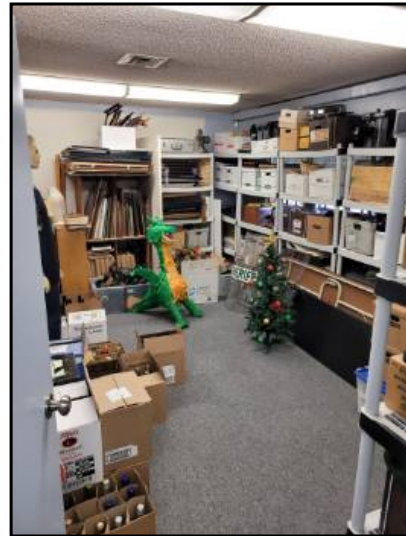
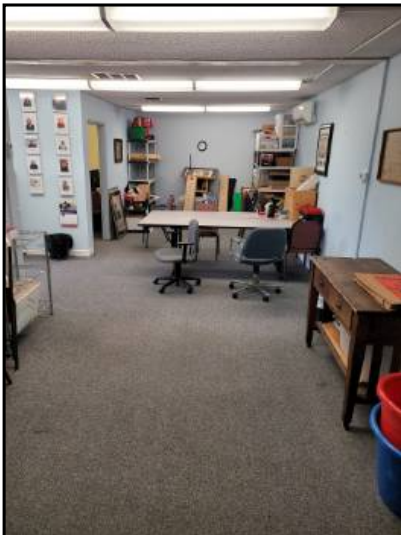
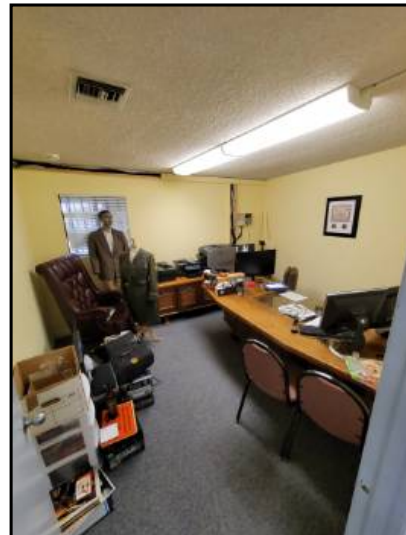
1.1. The general condition of the interior floor, walls, ceiling, windows, outlets are functional and in satisfactory condition.

1.2. Limited review of the interior during the time of inspection due to a number of personal items blocking access. Advise verifying condition with a qualified professional as needed.

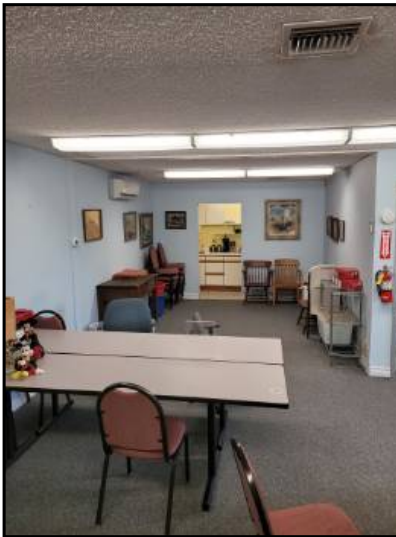
2.1. Acoustic texture, also known as "popcorn", was present at the ceilings. This material was often used from the late 1950s into the 1980s in residential construction. Some of this material installed before the 80's has been known to contain asbestos. It is beyond the scope of this inspection to test for asbestos. The only way to confirm the presence or absence of asbestos is by having a sample of the material tested in a lab. If client has any concerns regarding asbestos materials, an asbestos-testing lab should be consulted for further review.

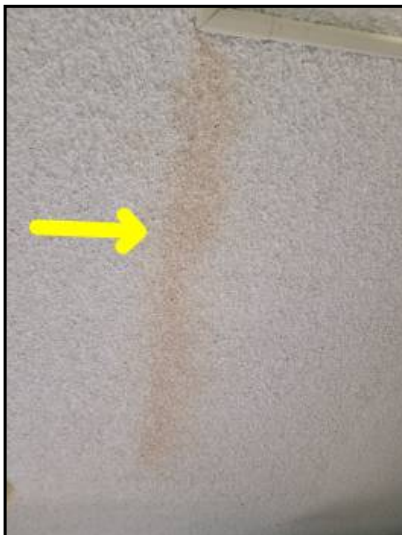
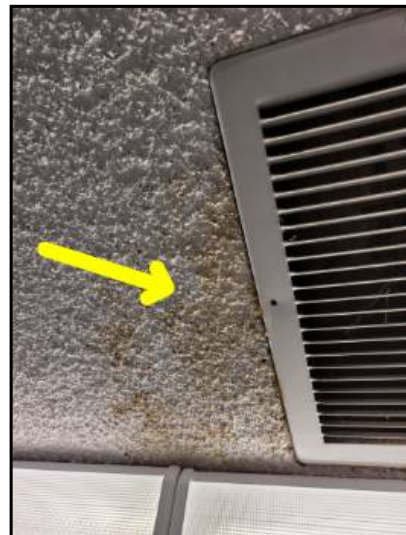
2.2. Evidence of water staining was observed at the second level ceiling in one or more areas. Conditions tested dry with the thermal imaging camera at the time of inspection. Refer to the sellers and sellers disclosure to advise. Monitor conditions.

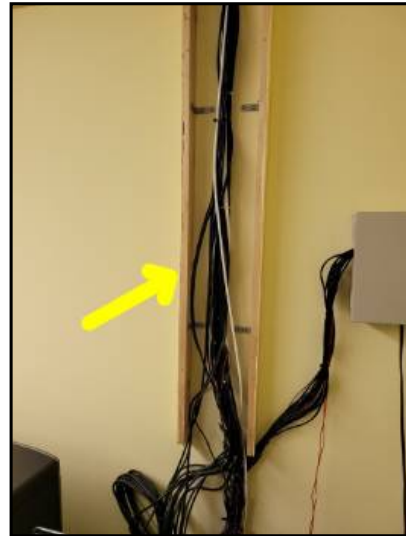
4.1. There are cover panels to the security system wiring that are missing.

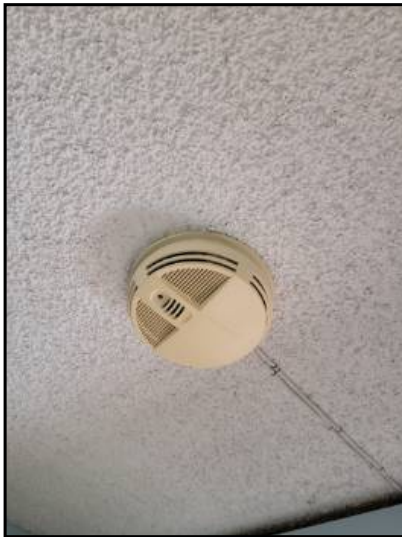
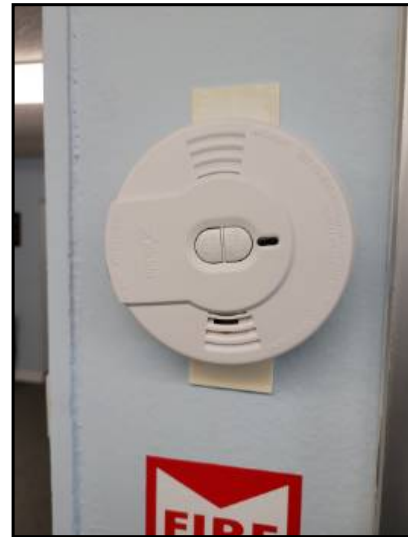
5.2. Some of the interior smoke detectors appear to be older (10+years old). According to the National Fire Protection Agency, smoke detectors should be replaced every ten years. Recommend replacing all original smoke detectors.

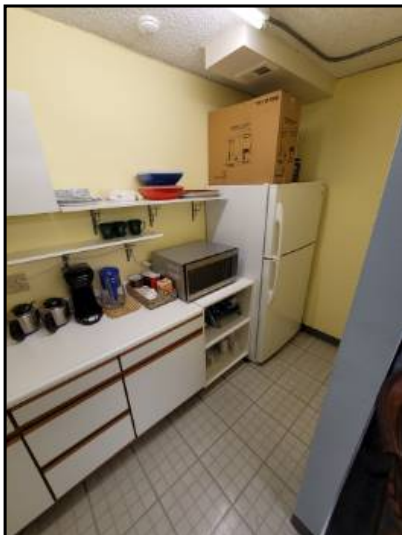
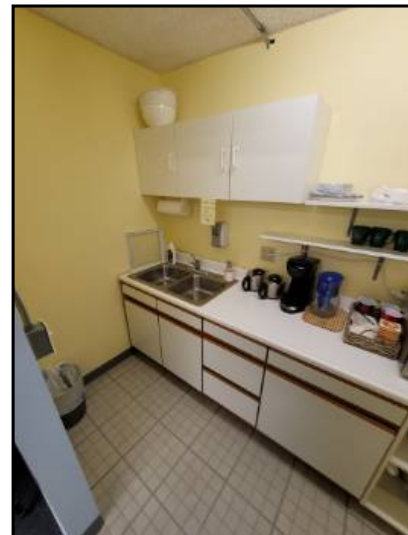
1.1. The general condition of the kitchen floors, walls, ceiling, windows, functional and in satisfactory condition.

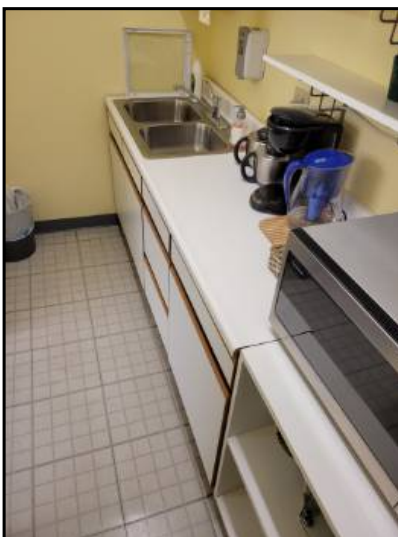
2.1. The kitchen counter tops are in acceptable condition.

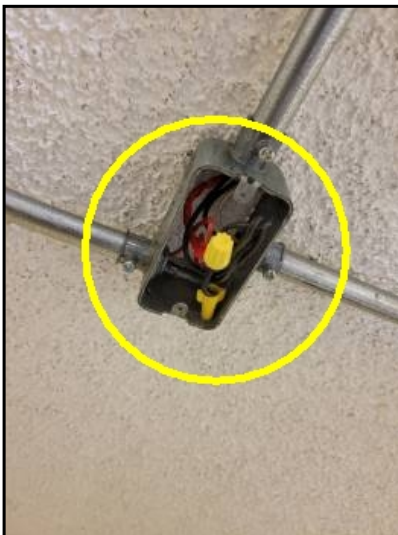
3.1. CAUTION: Unprotected wiring noted in one or more areas. This can be a possible safety concern. Recommend correcting advise repair by licensed electrical contractor.

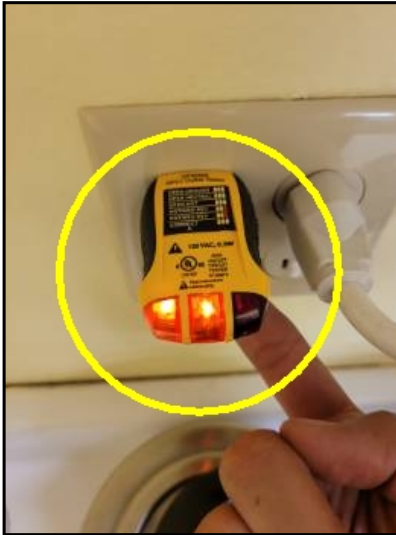
4.1. All Counter top outlets should be upgraded to have ground fault protection, which is mandated by current standards and is an important safety feature. Caution, potential safety shock hazard. Seek a licensed electrical contractor for repairs.

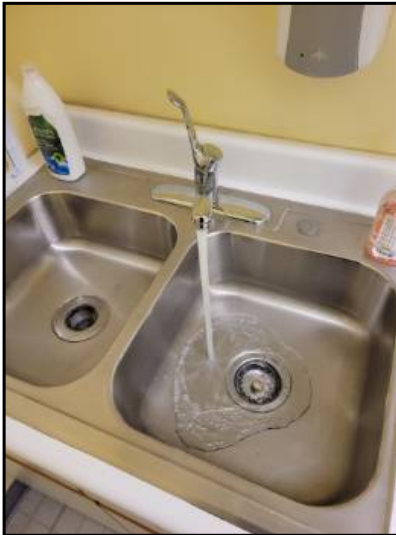
5.1. The kitchen sink valves and connector were functional at the time of inspection.

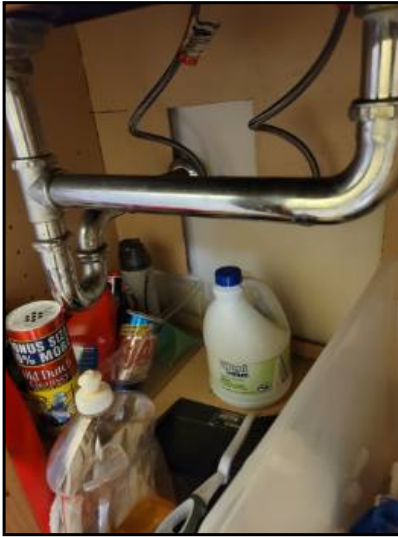
6.1. The sink drain P- trap and drain are functional.
